# Pavement Surface Evaluation and Rating Presentation

City of Oberlin  
Public Works Department  
July 5, 2011

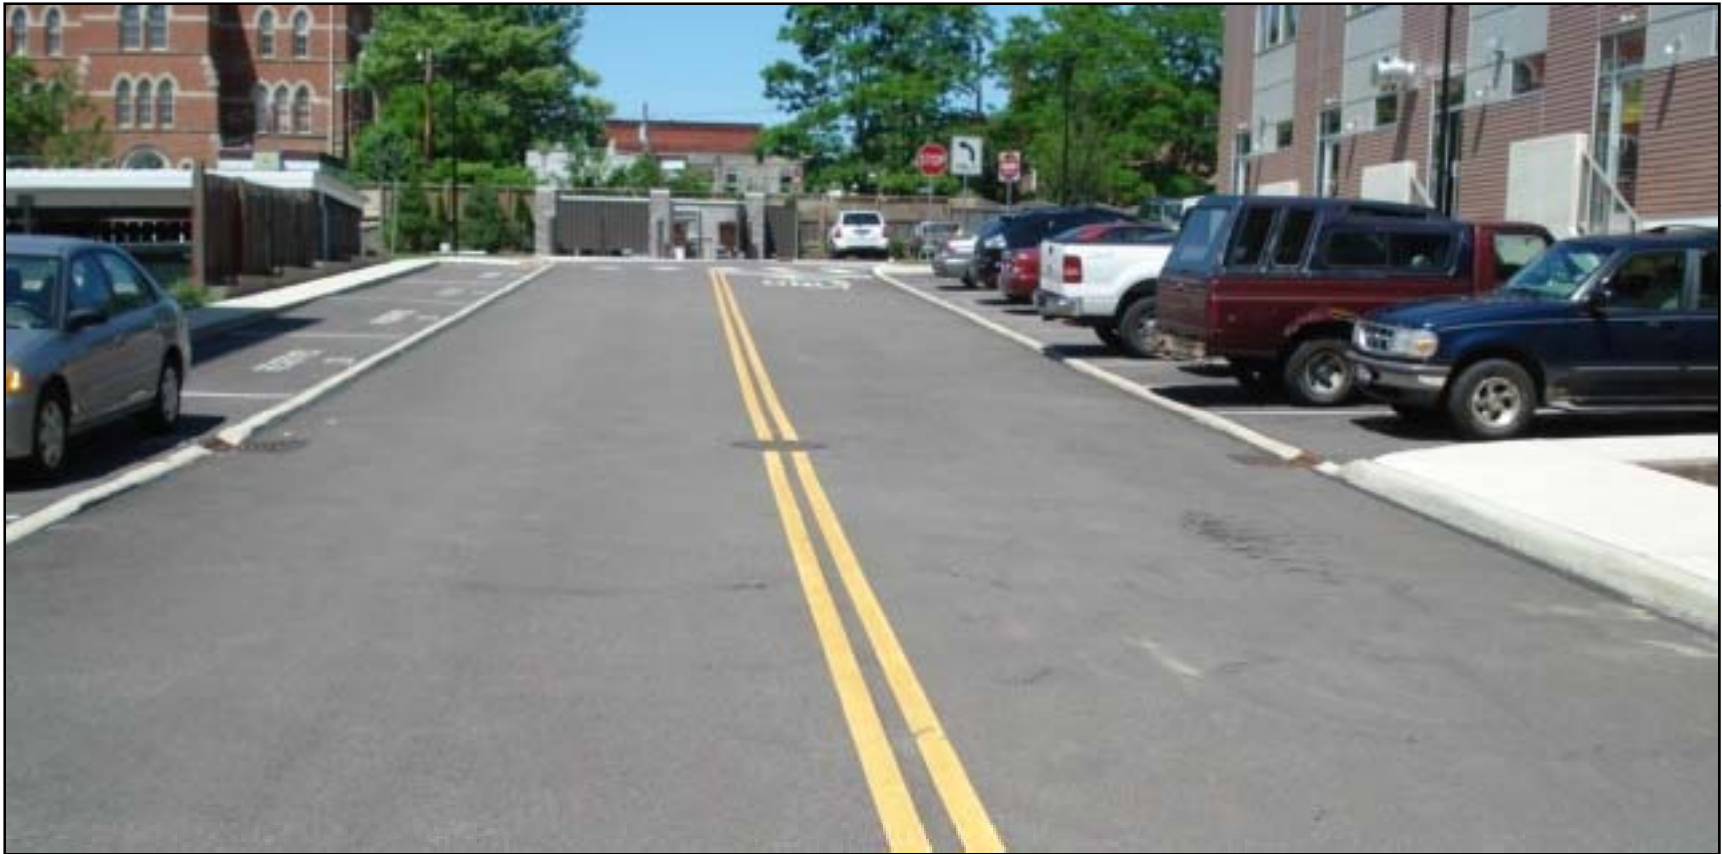
Eric Nord Way – Constructed 2010

New Construction – No maintenance required.

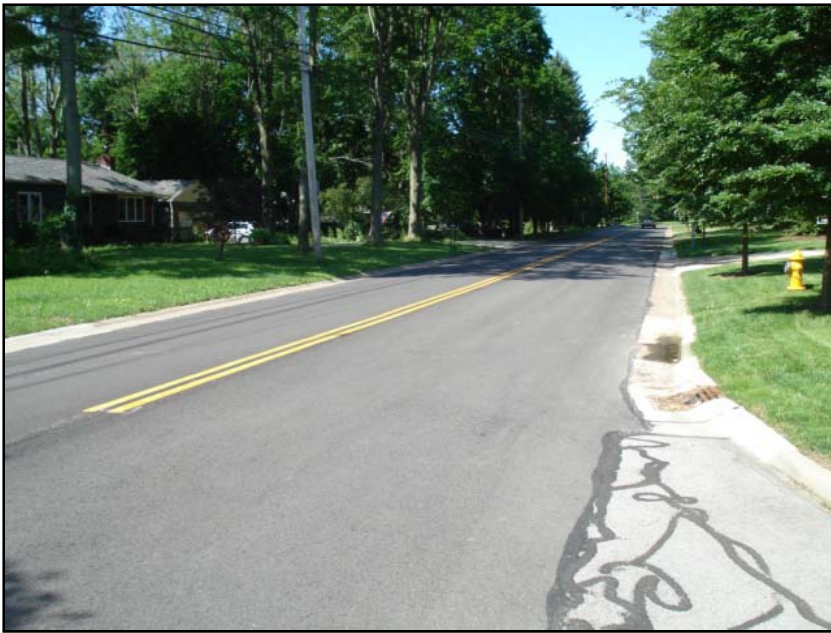
East College (Oberlin Rd to RT 511)

Recent Overlay. Like new. – No maintenance required.

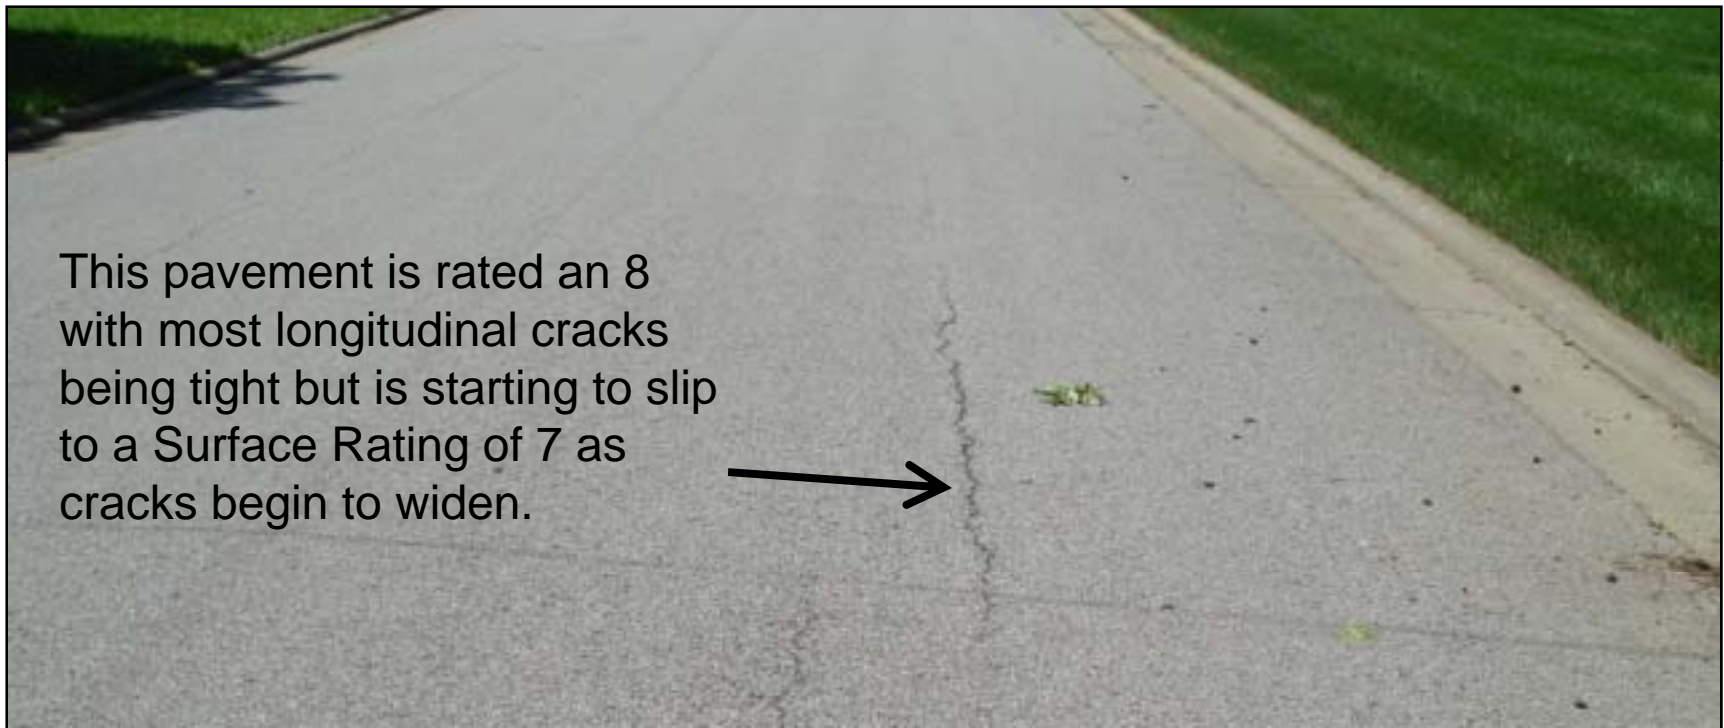
Fairway Dr.

Recent Overlay showing longitudinal or transverse cracks. All cracks are tight or sealed. Little or no maintenance required

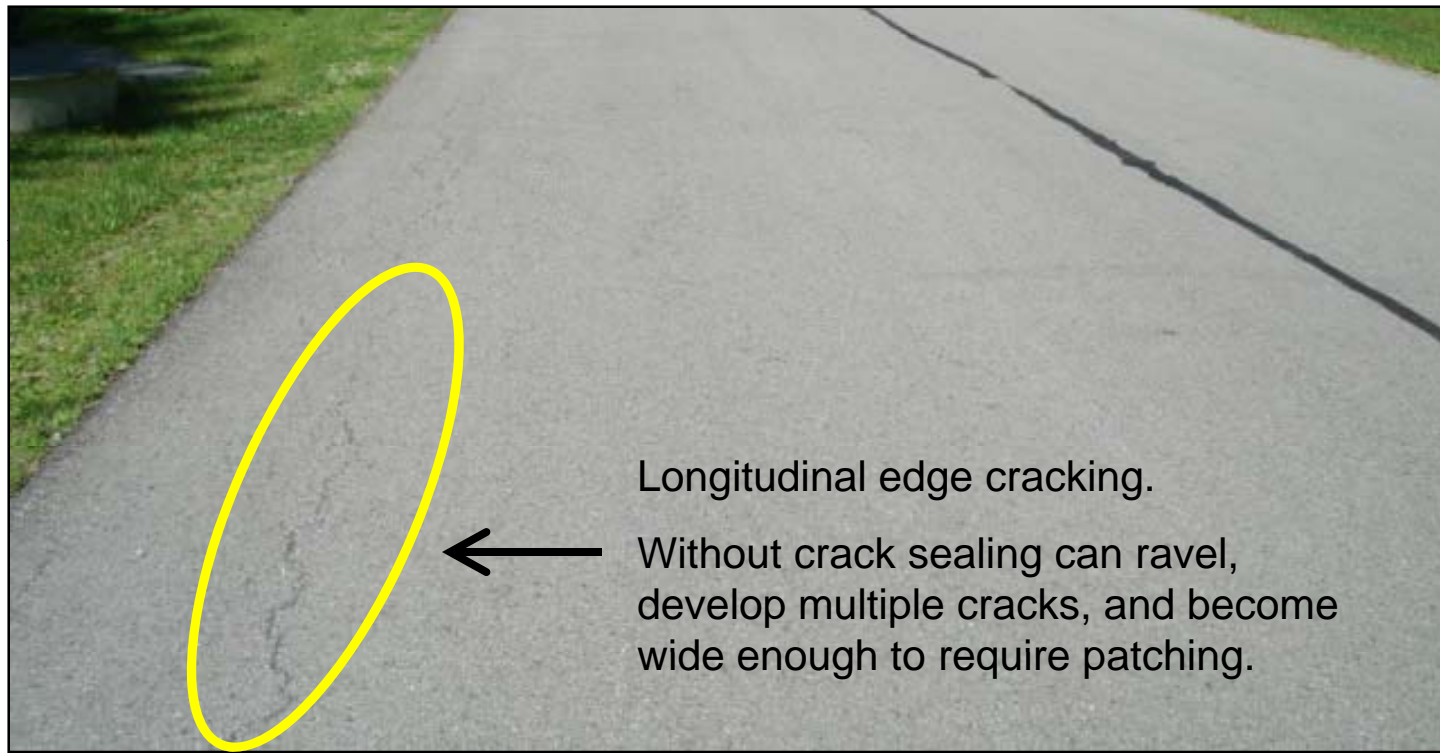
Hill Creek Dr.

First signs of aging. Maintain with routine crack filling.

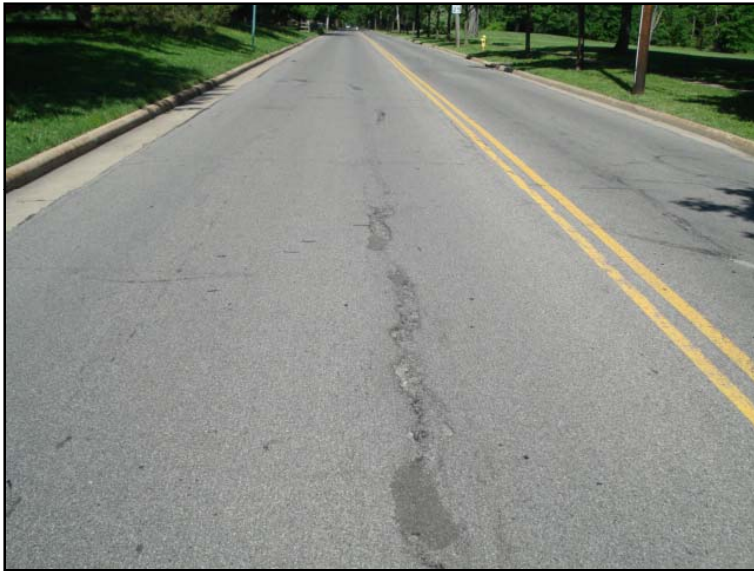
E. College  
(Orchard to Oberlin Rd.)

Large cracks forming small “pot holes” requiring patching.

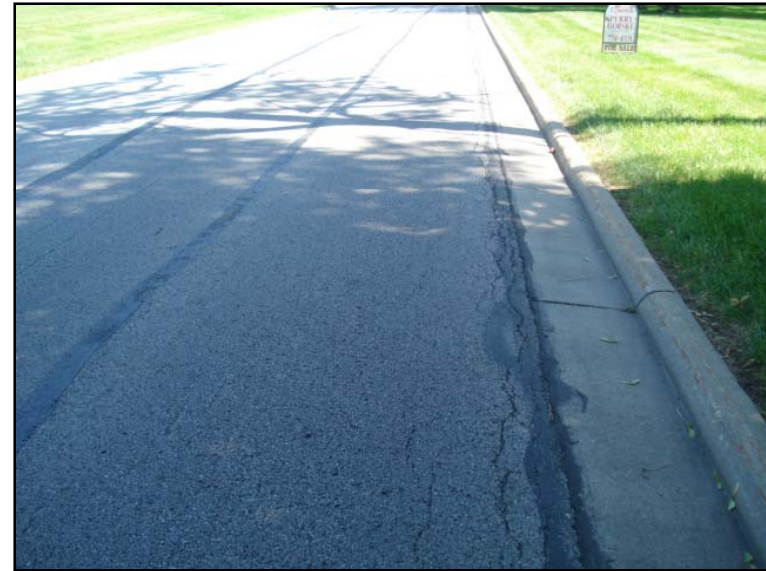
Oberlin Rd  
(Lorain to College)

Note multiple cracks forming along the curb.

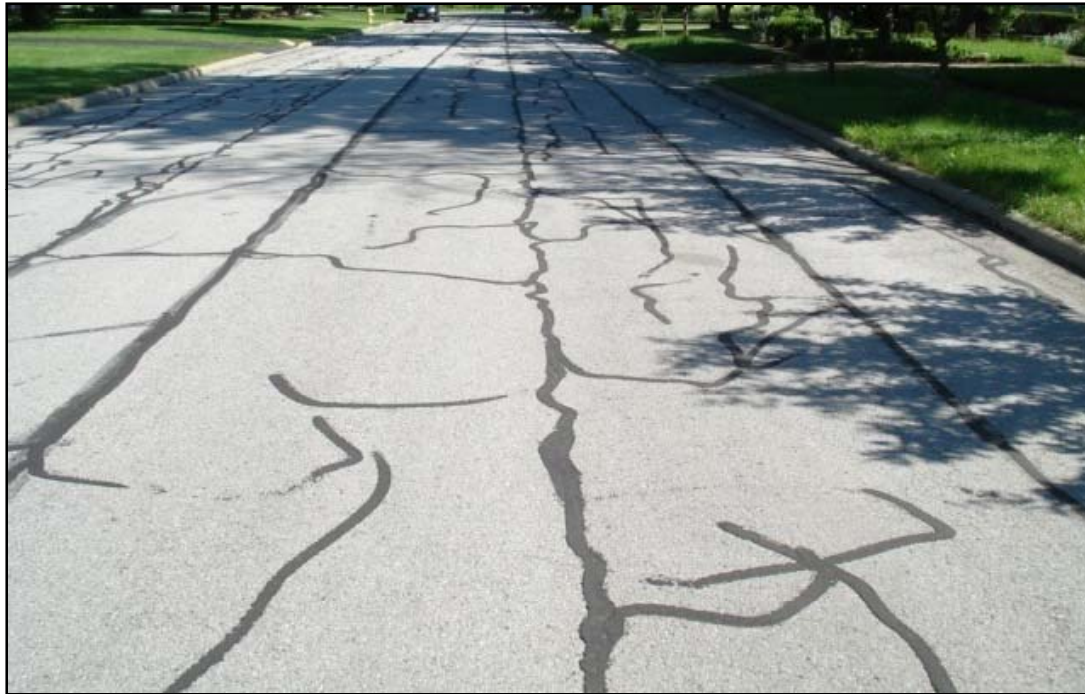
Thomas Street

Beginning stages of block cracking caused by shrinking and hardening of the asphalt over time.

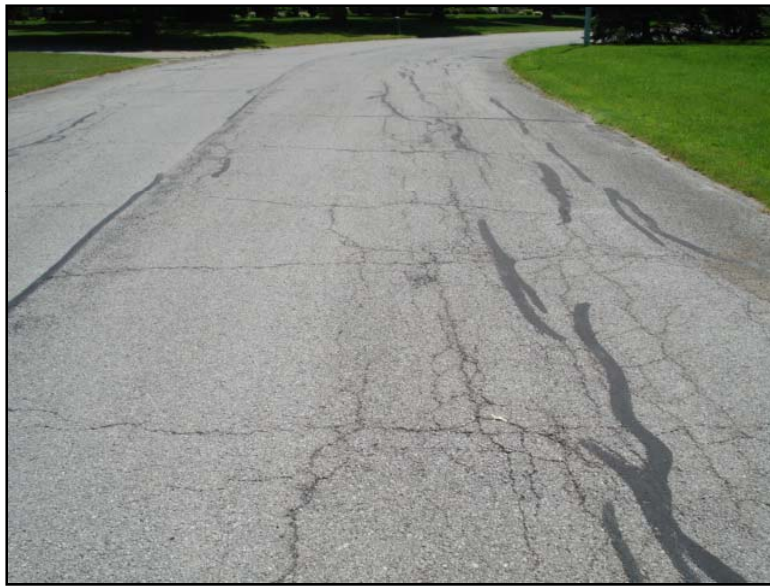
Robin Park

Cracking up to 50% of surface. Longitudinal cracking in the wheel path will move rating to a 4.

Roads are still in good structural condition but clearly need sealcoating or overlay.

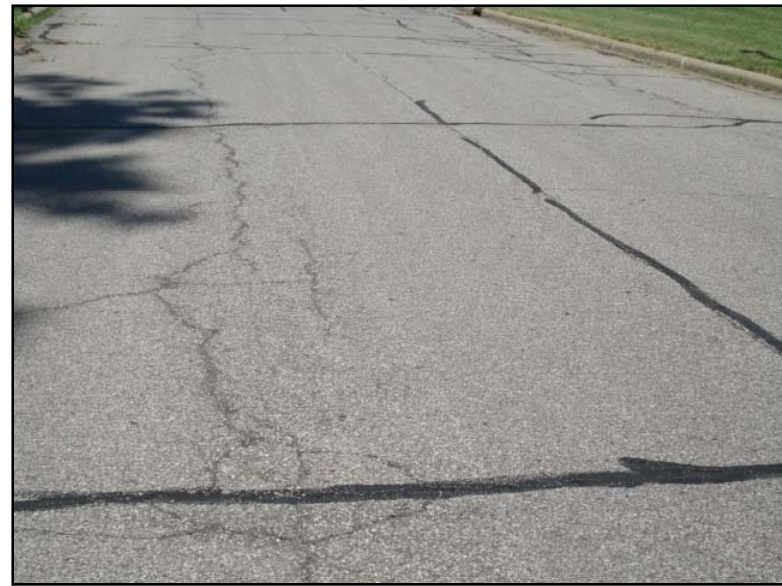
Stern

Block cracking up to 50% of surface. Cracks open to 1/2".

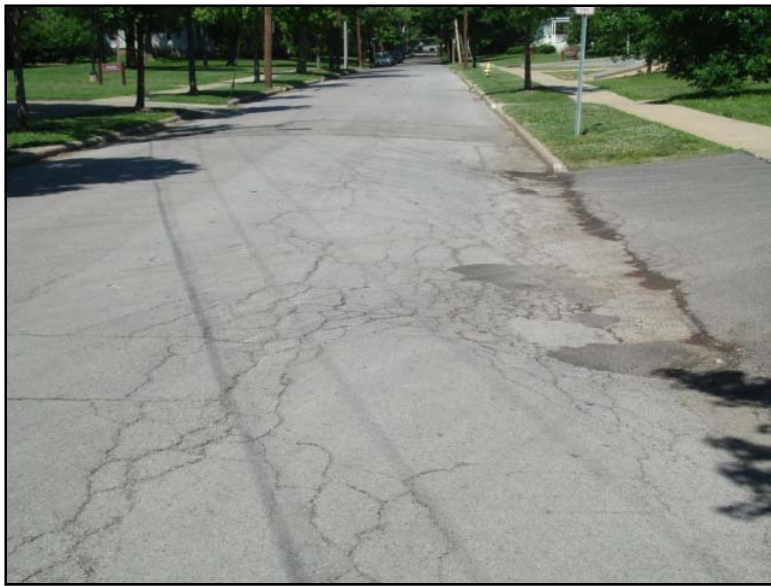
Elm (Professor to Prospect)

Extensive block cracking over 50% of surface. Patches in fair condition.

Roads show first signs of needing an overlay.  
Severe surface raveling which should no longer be sealed.

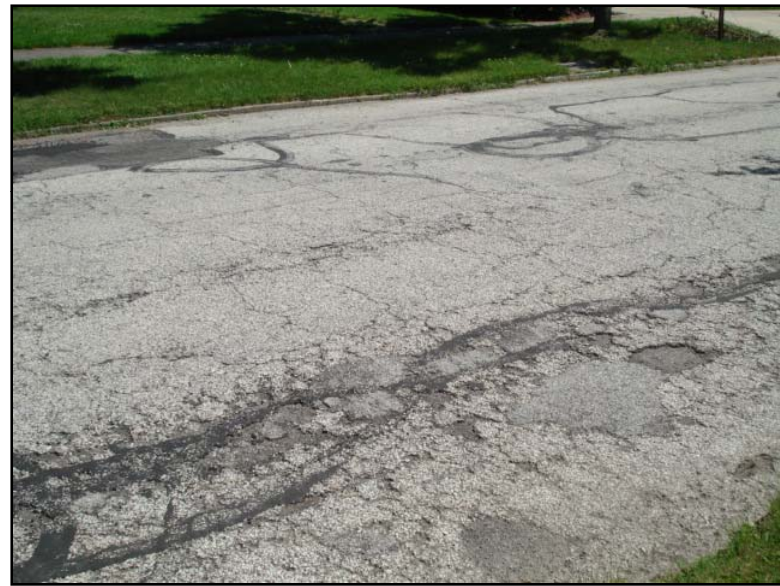
Forest

Severe raveling and loss of surface material.

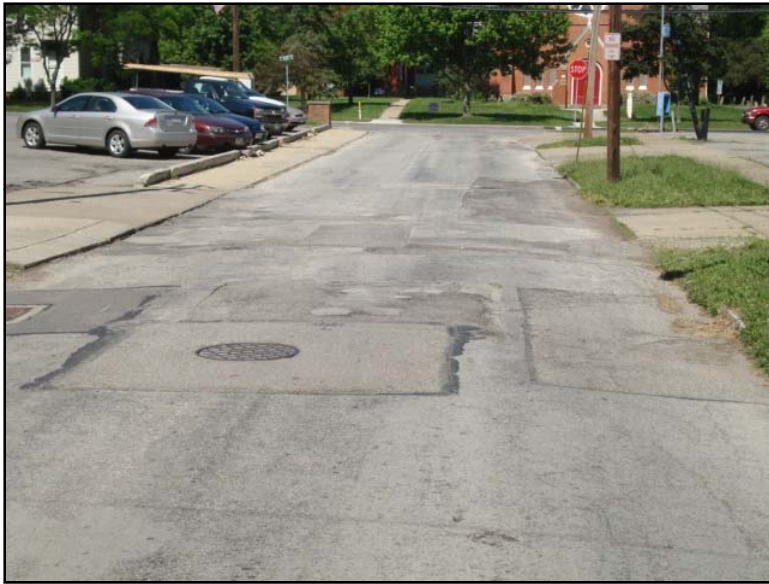
Groveland

Significant patches in fair condition.

Roads show first signs of needing an overlay.  
Severe surface raveling which should no longer be sealed.

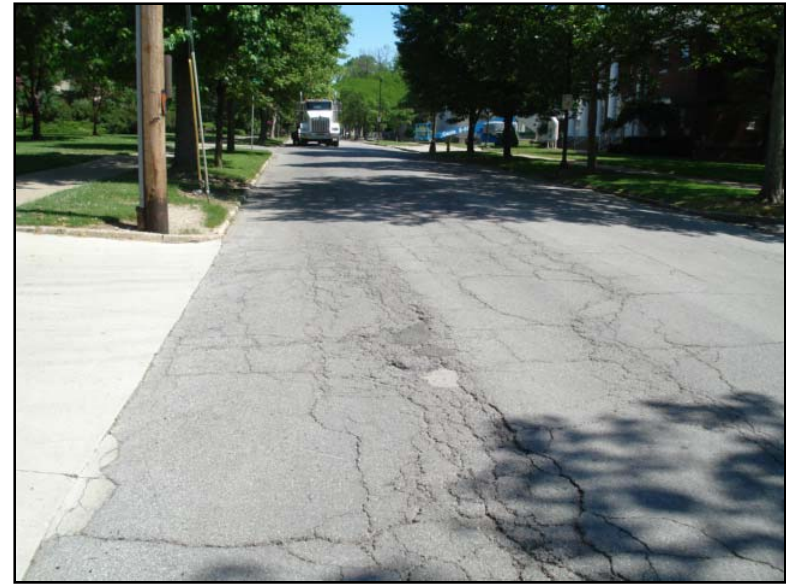
S. Professor

Longitudinal cracking in the wheel path. Beginning signs of alligator cracking (a level 3 condition).

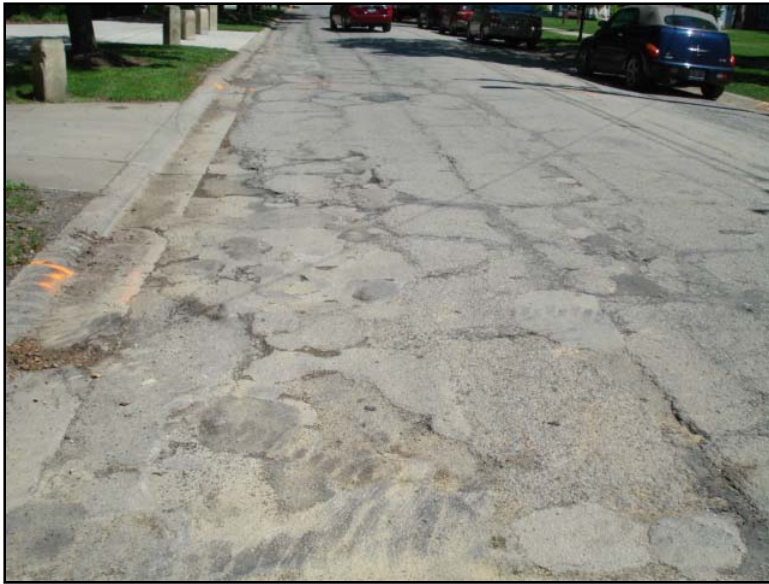
Woodland

Extensive patching in poor condition.

Will require select structural repair prior to milling and resurfacing.

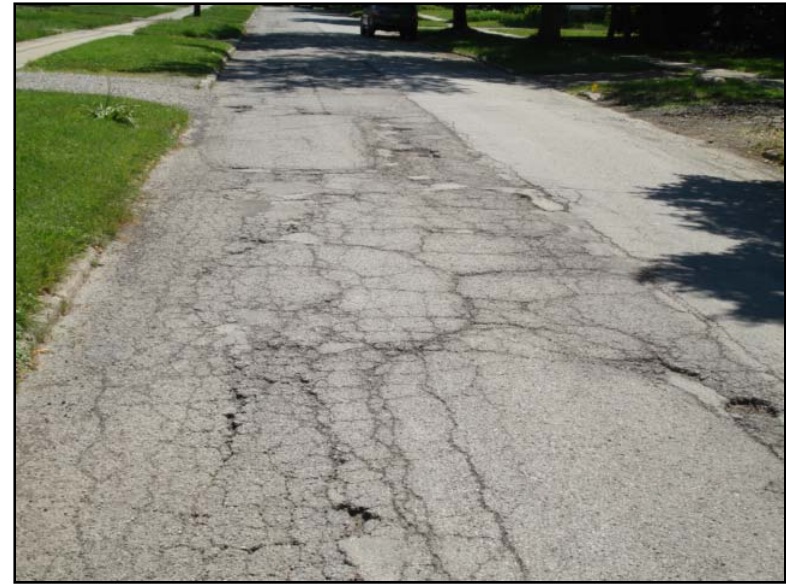
Union (Professor to Main)

Open raveled alligator cracking.  
Small potholes.

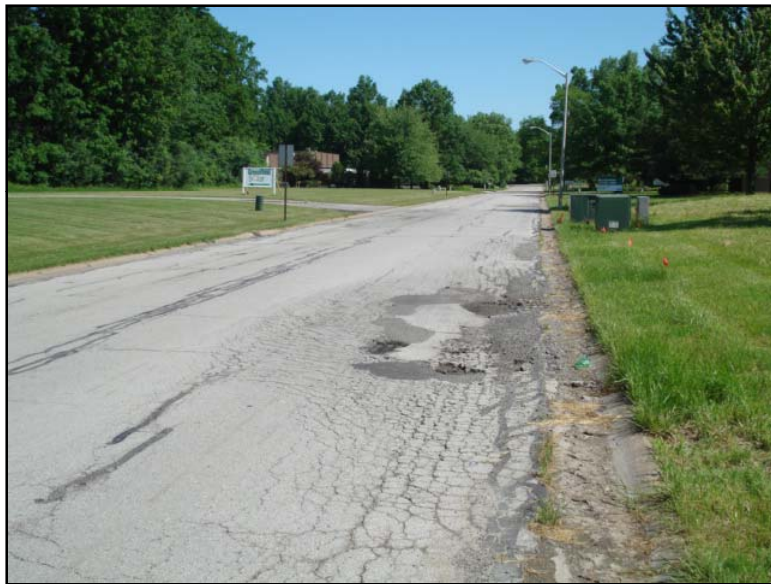
Artino

Severe alligator cracking on the edges. Distortion with patches in poor condition.

Will require select structural repair prior to milling and resurfacing.

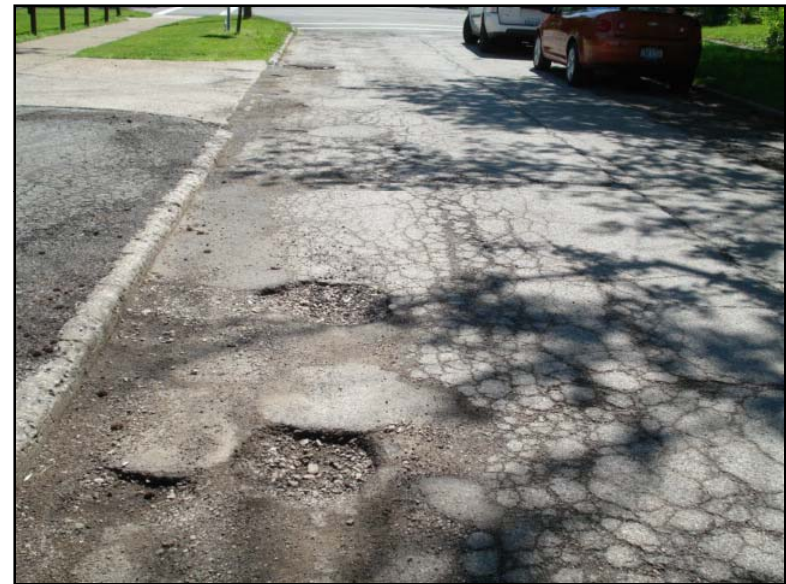
Elm (Prospect to cul-de-sac)

Severe alligator cracking with small potholes.

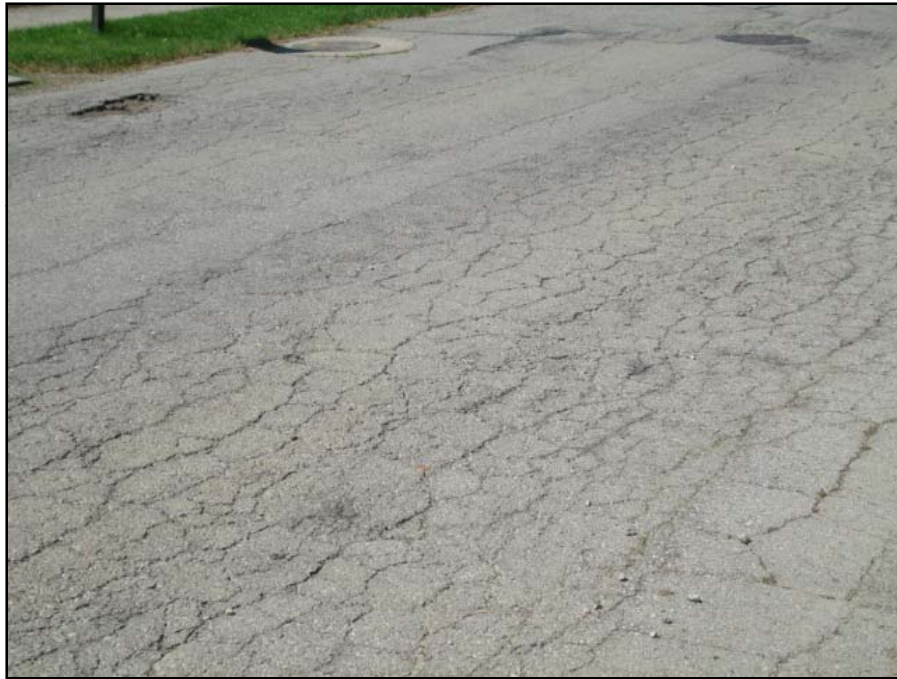
Sumner

Severe alligator cracking over 75% of surface (criteria is 25%). Potholes, patches, and rutting.

Severely deteriorated. Normally needs reconstruction.
