DAM SAFETY INSPECTION REPORT

OBERLIN WATERWORKS UPGROUND NO. 1&2

FILE NUMBER: 1221-018

INSPECTED: SEPTEMBER 18, 2018

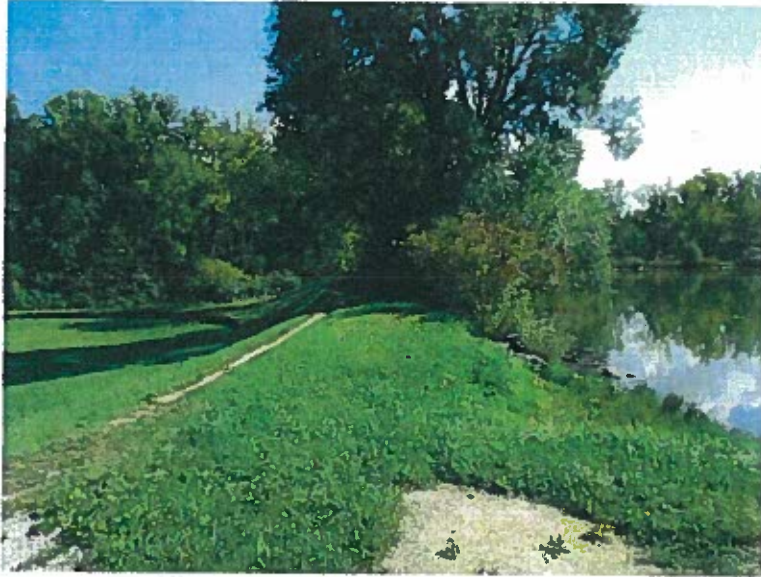
1. The east embankment along Reservoir No. 1.

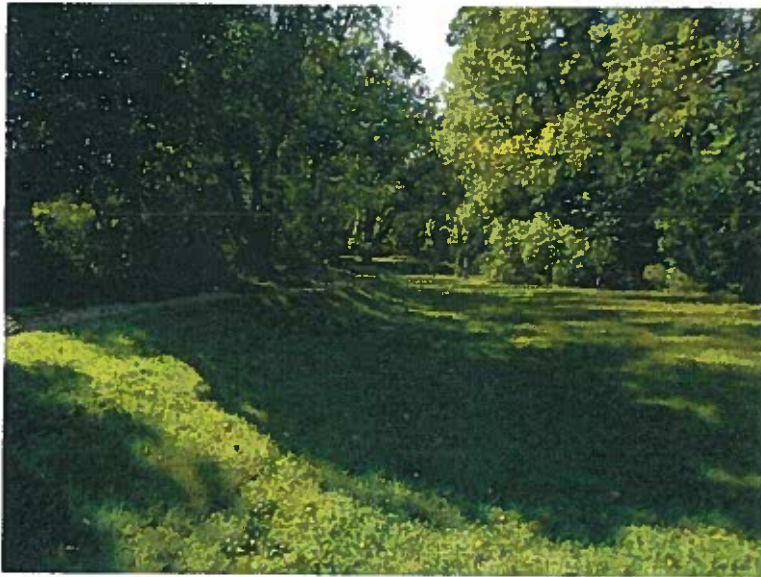
2. The north embankment along Reservoir No.1.

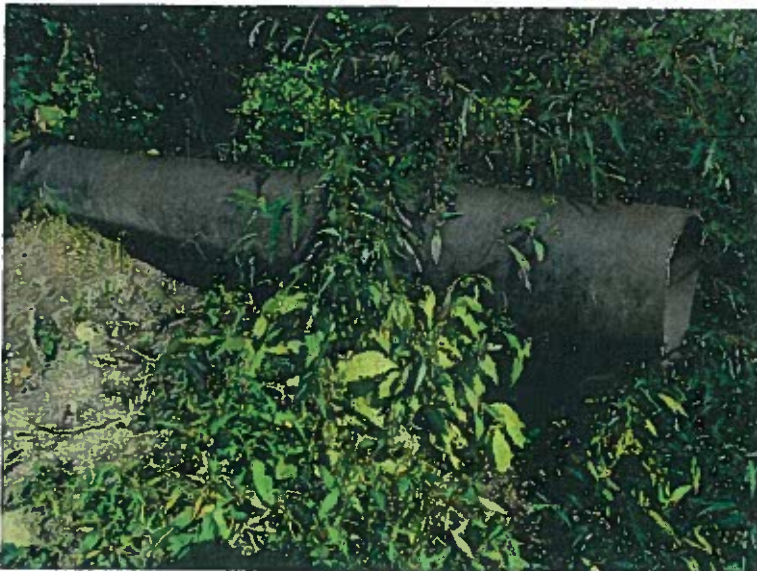
3. One of multiple unused piping located within the embankment.

4. The unused and abandoned piping must be removed or properly abandoned. Prepare plans and specifications for removal or abandonment. The condition of the unused and abandoned piping must be monitored quarterly until repairs can be made. See Discussion Item #4 included in this section for additional information.

4. The deterioration of an old or unused pipe can lead to structural collapse or seepage along the pipe. As a result, piping can occur. Piping is when soil particles are carried out of the dam with the seepage, leaving voids in the embankment. Piping will lead to failure of the dam. Unused or old piping should be removed or properly abandoned in place. Abandoning in place requires the entire pipe to be filled with concrete or grout. Both alternatives must be completed under the supervision of a registered professional engineer.

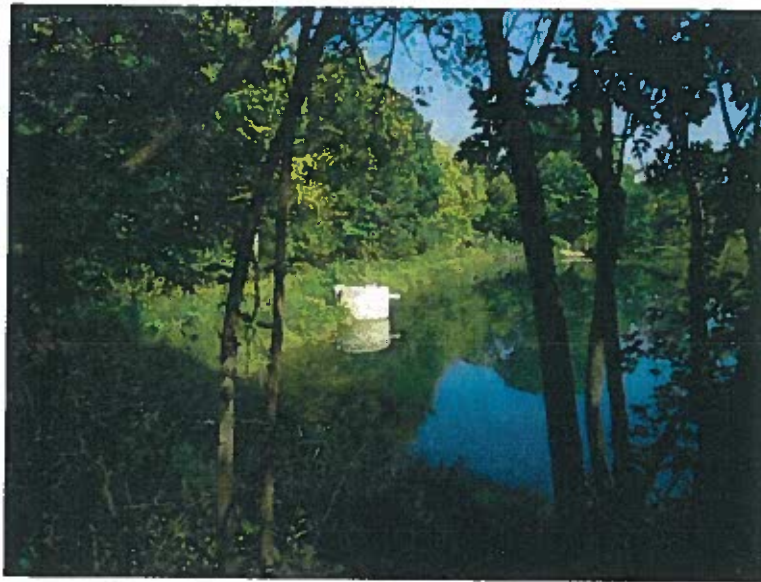
4. The old masonry riser in Reservoir No. 2.

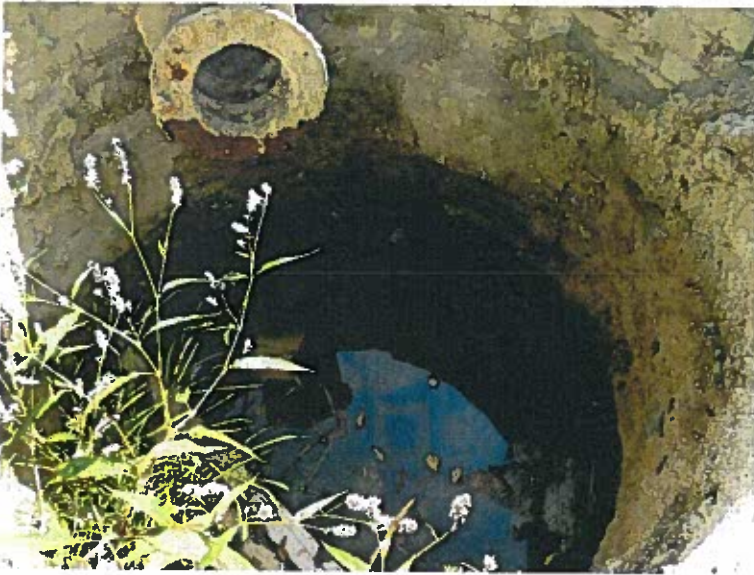
5. Interior of the masonry riser.

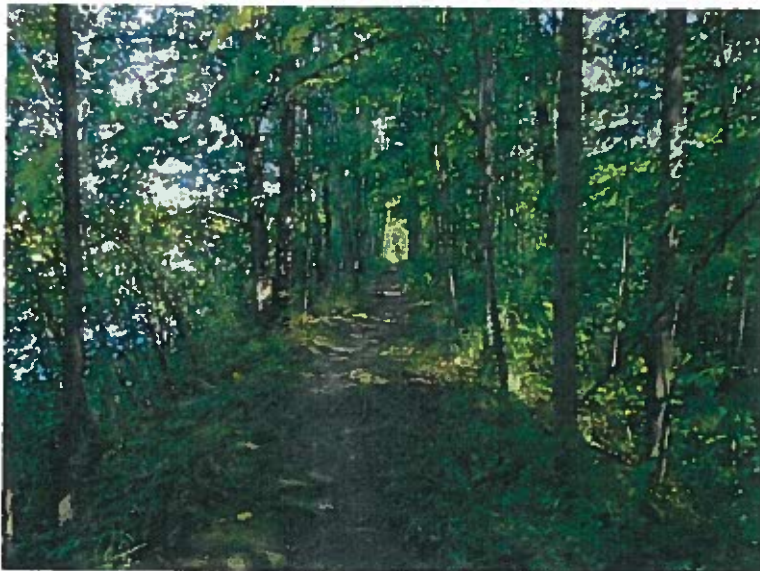
6. Dense trees and brush covered the majority of the embankment.

Notice the bare areas from the pedestrian footpath.

1. Remove the trees and brush from the entire embankment. Seed all disturbed areas to establish a proper grass cover. See the "Trees and Brush" fact sheet for additional information.

5. Repair the rodent burrows on the entire embankment. See the "Rodent Control" fact sheet for additional information.
6. Repair the footpaths on the crest. See the "Ground Cover" fact sheet for additional information.

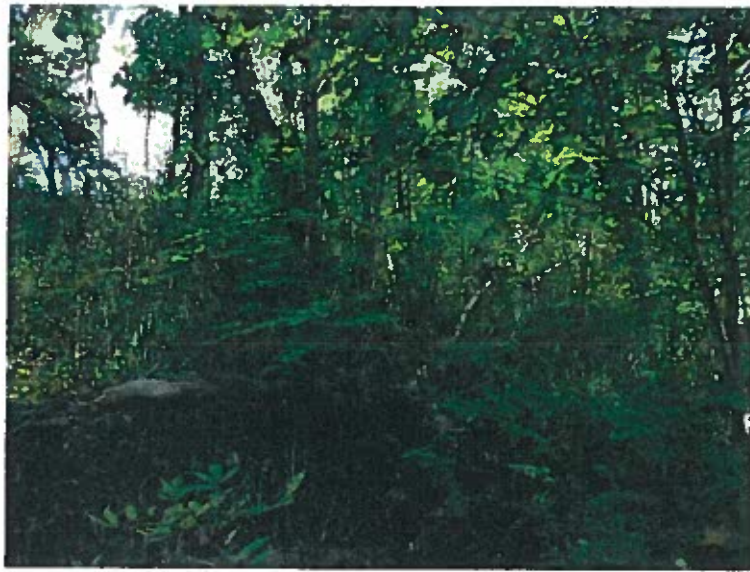
7. Dense trees and brush obstructed visual inspection of the exterior slope.

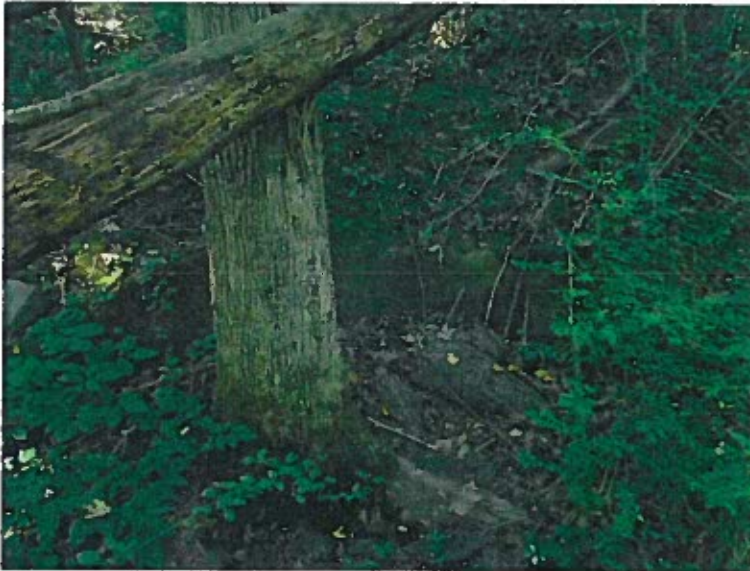
8. A concrete headwall was located along the southern exterior toe of Reservoir No. 2.

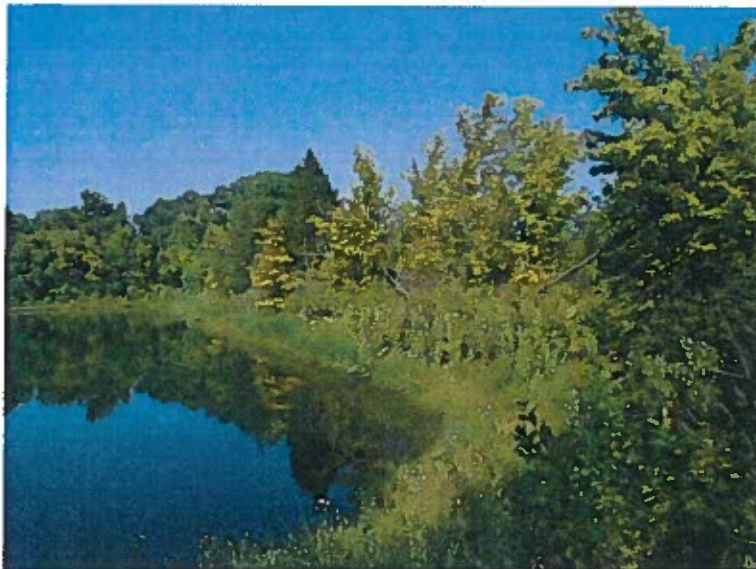
9. The common embankment between the two reservoirs.

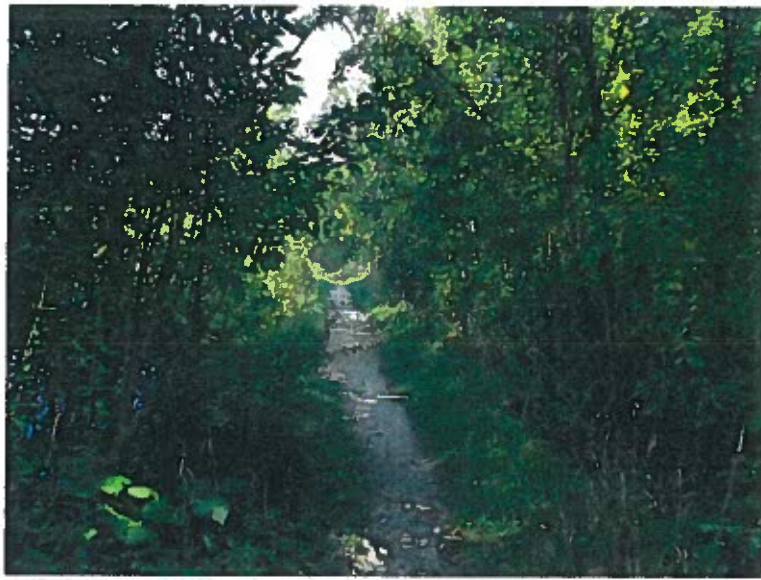
10. The embankment along Reservoir No. 1.

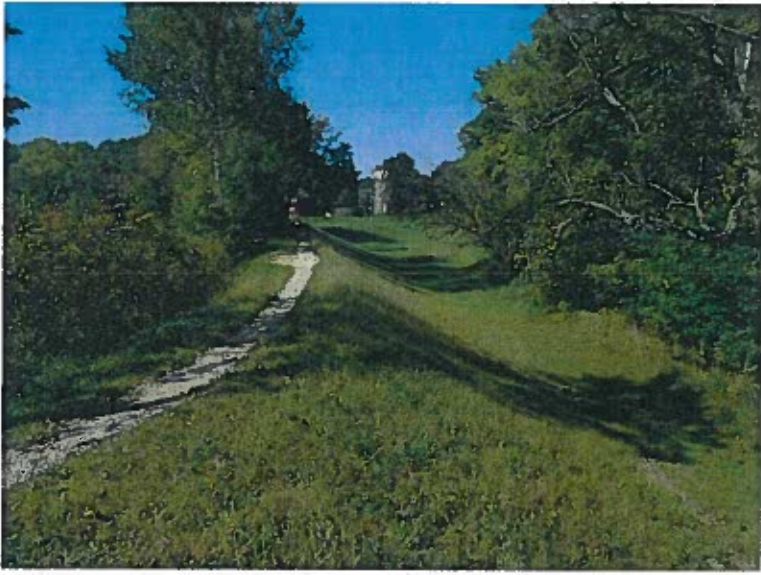
11. The east embankment along Reservoir No. 1.

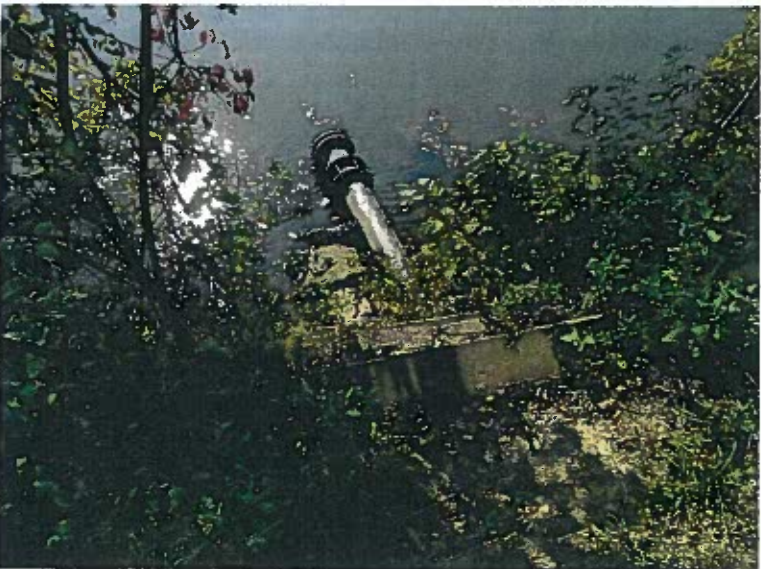
12. The emergency overflow pipe located in Reservoir No. 1.

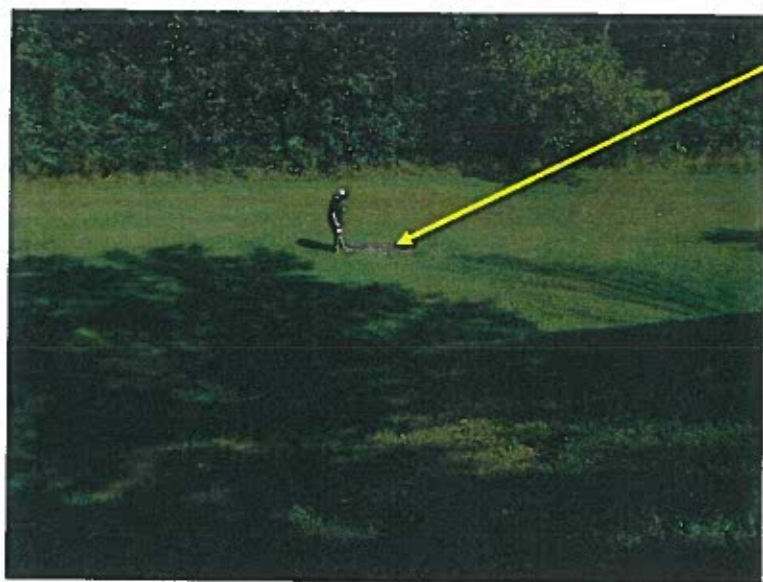
13. The emergency overflow pipe catch basin located at the exterior toe of Reservoir No. 1.

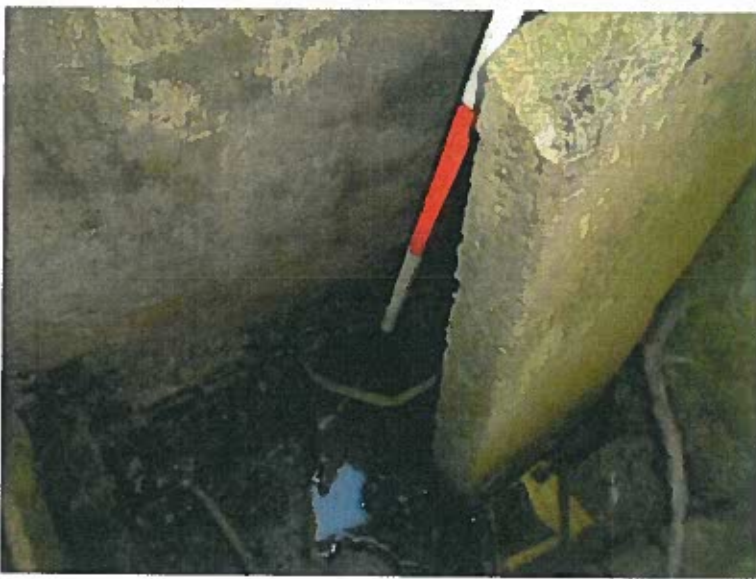
14. The interior of the catch basin in photograph no. 13.

Notice the obstructions in the catch basin.

7. Remove the obstructions from the emergency overflow catch basin.
