TRAFFIC ENGINEERING STUDY

Various Crosswalk Locations

Oberlin, Ohio

November 14, 2007

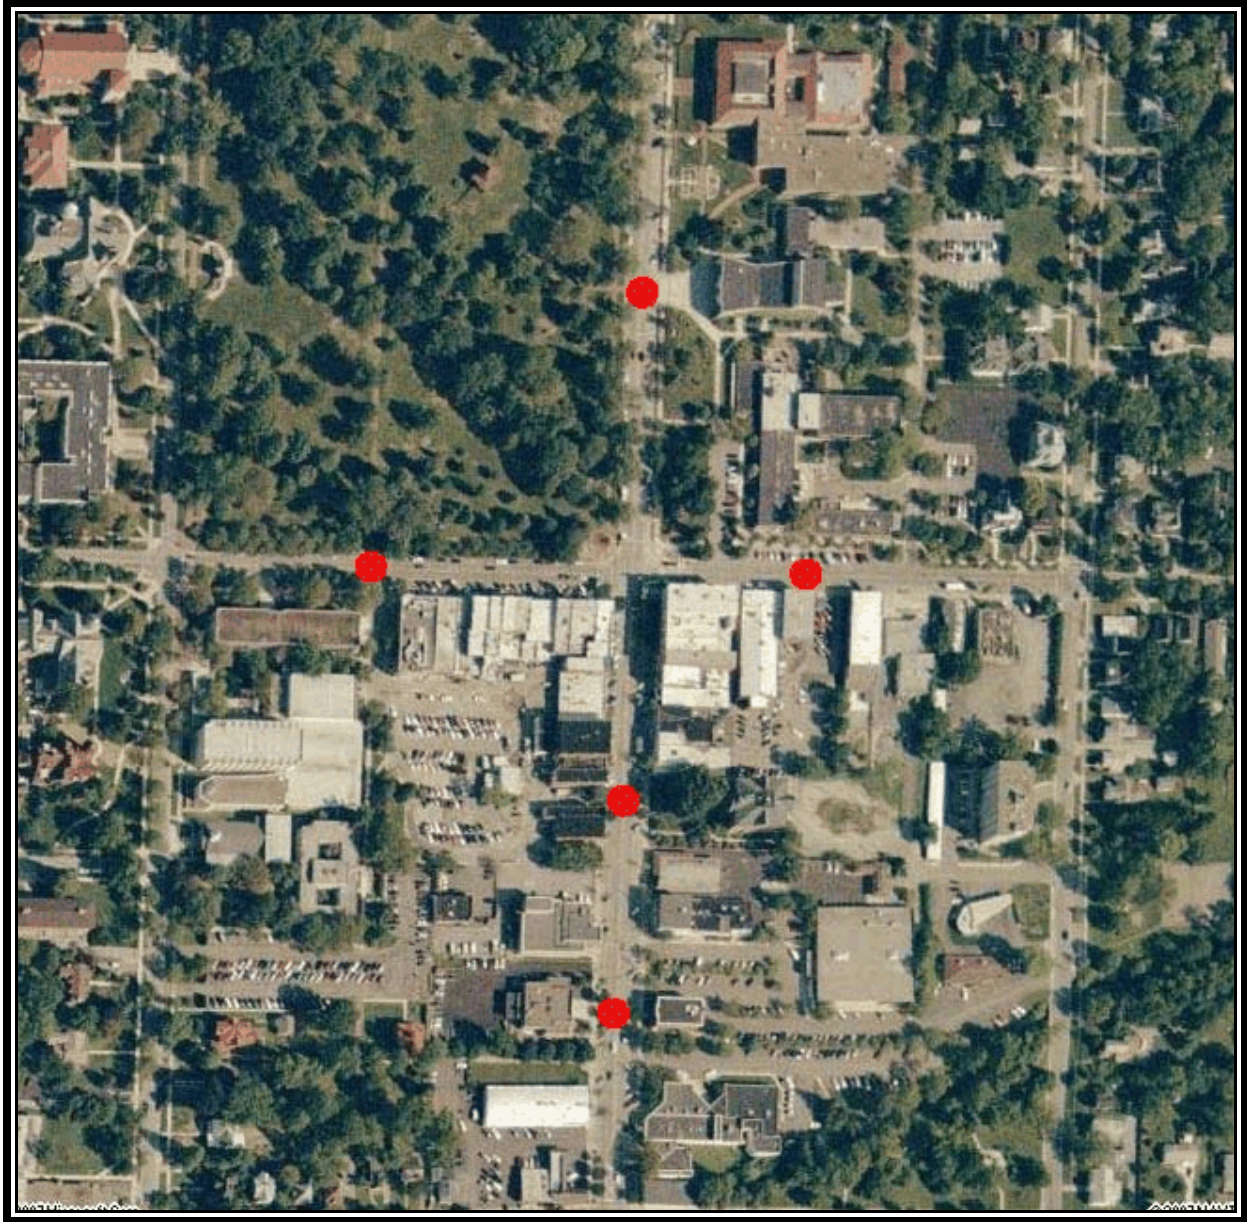
Figure 2 - Aerial View

Figure 2, Page 5 shows an aerial view of the study area and the crosswalk locations. **Figure 3, Page 6** shows the existing study area lane use and traffic control conditions.

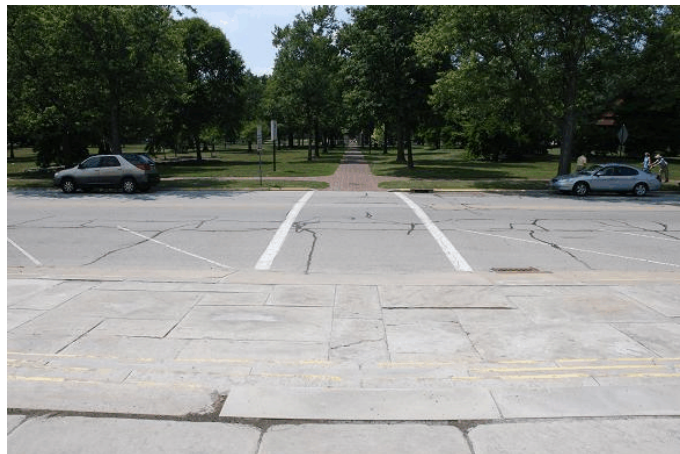
This crosswalk is located along North Main Street between Lorain Street to the north and College Street to the south. The crosswalk provides a connection across North Main Street from Tappan Square to the west and several Oberlin College buildings to the east.

North Main Crosswalk Looking West

The curb ramps at the North Main crosswalk should be retro-fitted with a detectable warning surfaces consisting of truncated domes.

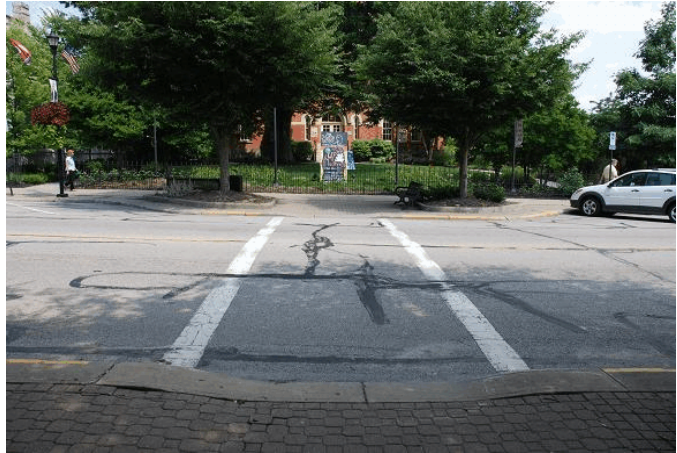
This crosswalk is located on South Main Street between Vine Street to the south and College Street to the north. The crosswalk provides a connection between the commercial and municipal buildings along South Main Street. There is an Army-Navy surplus store located at this crosswalk.

South Main Crosswalk Looking East

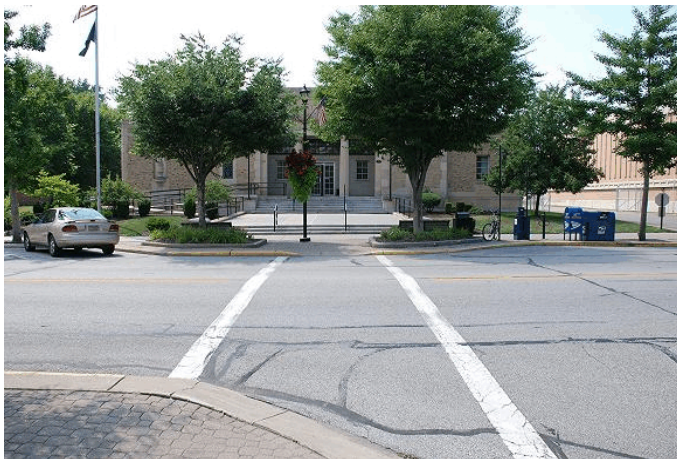
This crosswalk is also located on South Main Street between Vine Street to the south and College Street to the north. Is located south of the crosswalk referred to as the South Main crosswalk. This crosswalk provides a connection between the commercial and municipal buildings along South Main Street. This crosswalk is referred to as the Old City Hall crosswalk since the former city hall building is located at this crosswalk along the east side of South Main Street.

Old City Hall Crosswalk Looking West

The curb ramps at the Old City Hall crosswalk should be retro-fitted with a detectable warning surfaces consisting of truncated domes. It should also be noted that the east curb ramp does not line up directly with the crosswalk. The curb ramp is on an angle that would discharge pedestrians into the roadway outside of the marked crossing. A pedestrian using such a ramp may enter the intersection outside of the marked crosswalk, or a visually impaired person is aimed away from the crosswalk and into traffic. This proves especially difficult for wheelchairs as the person would have to redirect themselves after exiting the curb ramp to remain within the confines of the crosswalk. Future consideration should be give to re-aligning the curb ramp so that it lines up with the crosswalk.

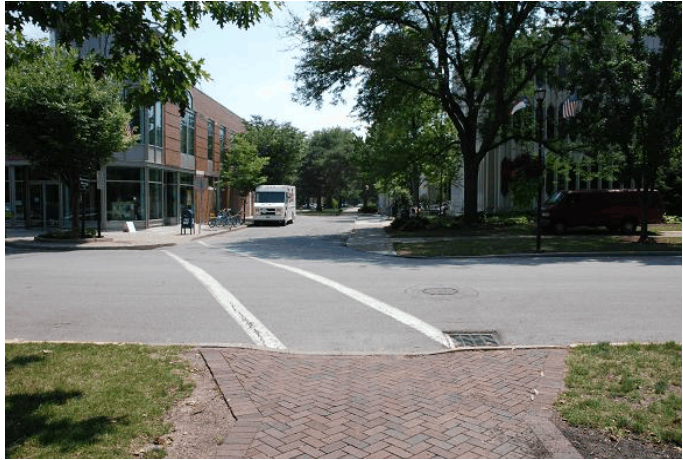
This crosswalk is located on West College Street between Professor Street to the west and Main Street to the east. The crosswalk is at the intersection of West College Street and College Place. The crosswalk runs diagonally across West College Street from the southeast corner of the intersection to the northwest corner. This crosswalk provides a connection between Tappan Square on the north side of West College Street and several storefronts including the Oberlin College bookstore along the south side of College Street.

West College Crosswalk Looking South

The curb ramps at the West College crosswalk should be retro-fitted with a detectable warning surfaces consisting of truncated domes. With the relocation of the existing crosswalk to the southwest corner and the addition of a marked crosswalk across the College Place approach the southwest corner should have an adequate curb ramp design with detectable surfaces for the use of both crosswalks.

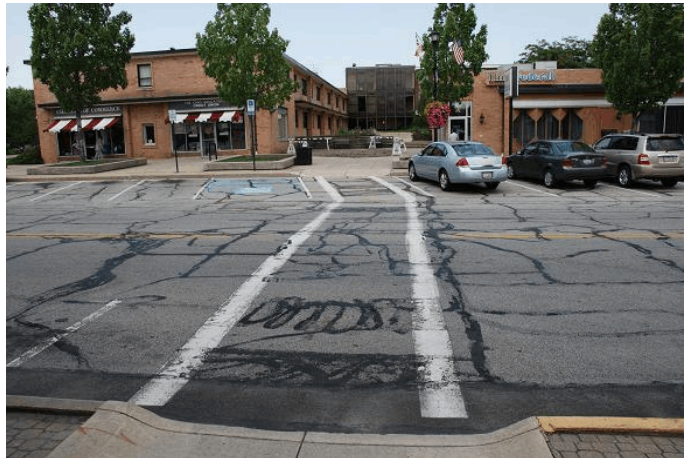
The East College Crosswalk is located on East College Street between Main Street to the west and Willard Court to the east. This crosswalk provides a connection between the commercial and municipal buildings along East College Street.

East College Crosswalk Looking North

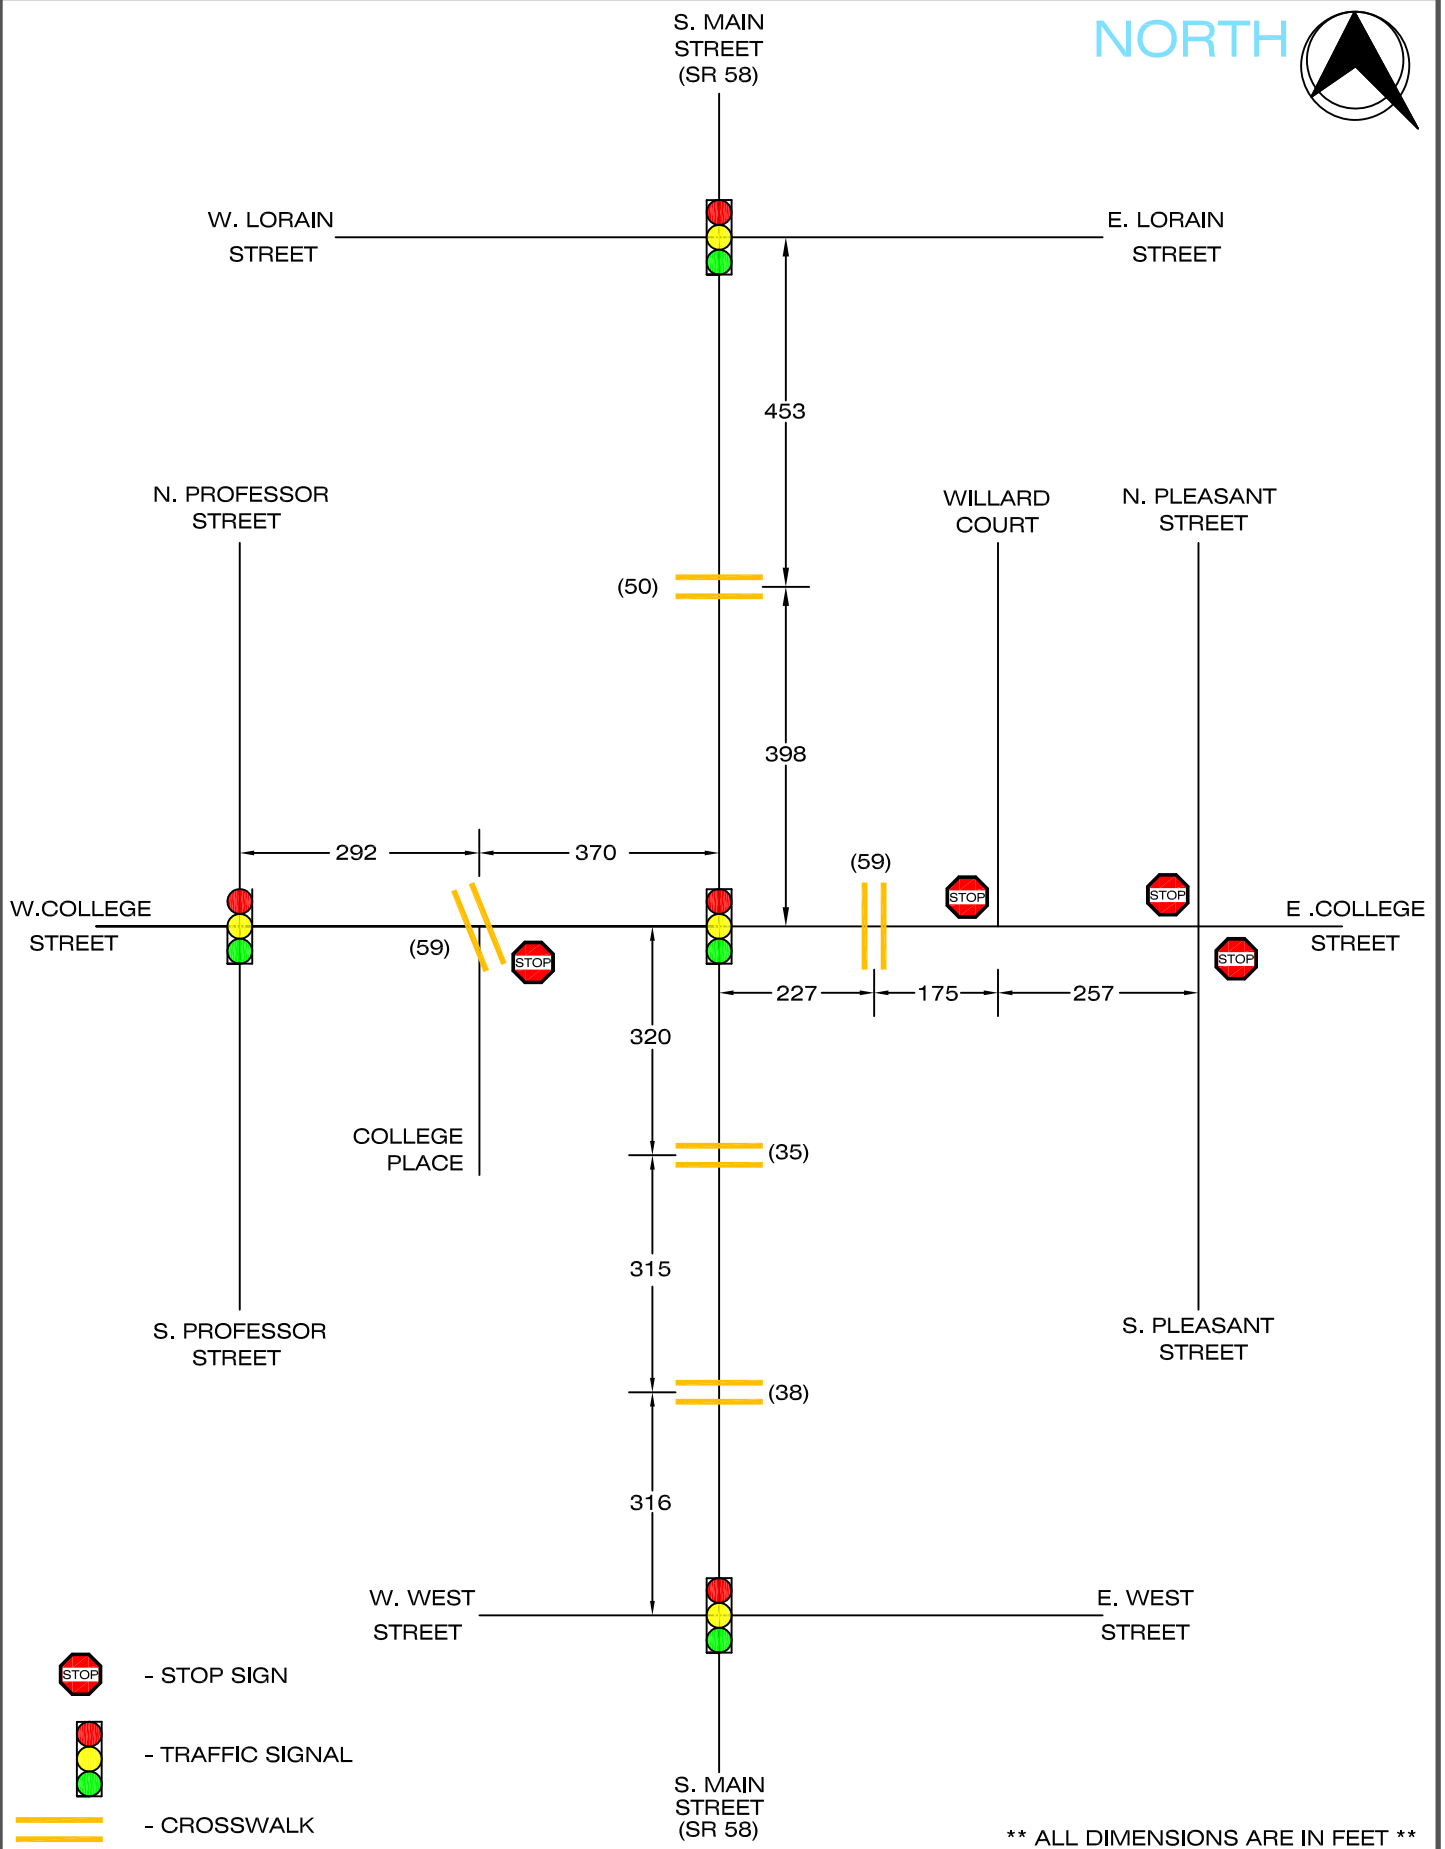
Figure 4, Page 10 shows the location of the crosswalks and the distance between them and the adjacent intersections where marked crosswalks exist as well as signalized pedestrian crossing facilities at the signalized intersections. The curb to curb widths of the crosswalks are also shown in the drawing in parentheses next to the crosswalk indication.

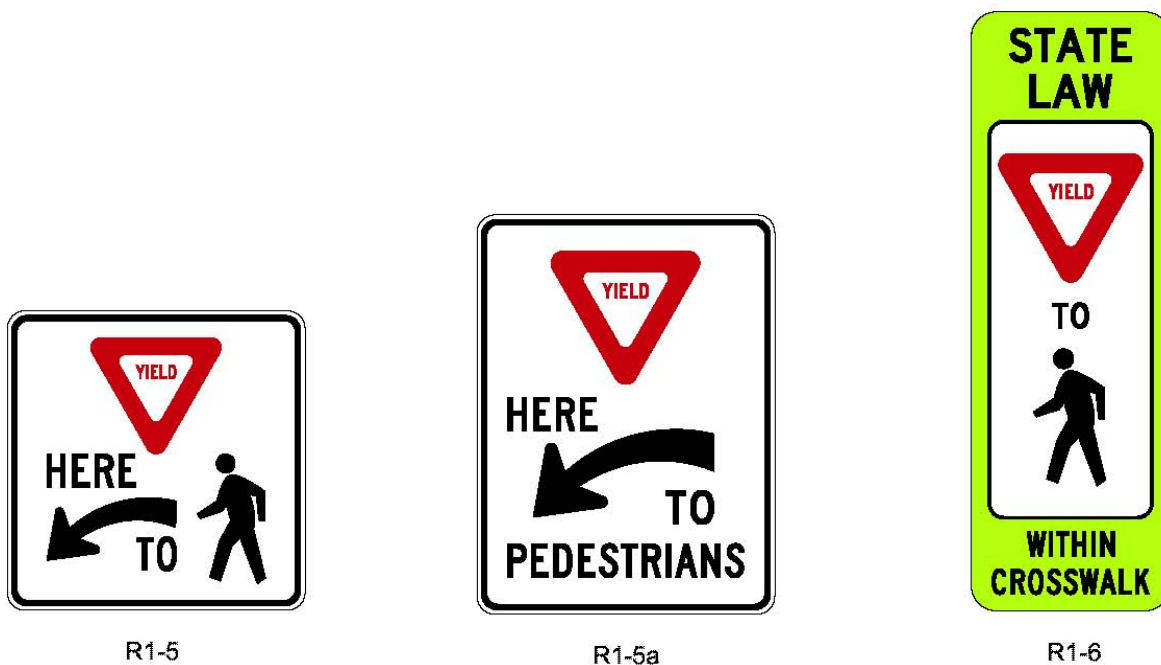
Figure 6 - Unsignalized Intersection Crosswalk Signs

Regulatory signs for use at mid-block crossings can be seen in **Figure 6**. The sign code as assigned in the **OMUTCD** is shown below the signs. This code is used to identify the sign and its type.

If yield lines are used in advance of a marked mid-block crosswalk, Yield Here To Pedestrians (R1-5 or R1-5a) signs shall be placed 20 to 50 ft in advance of the nearest crosswalk line. The In-Street Pedestrian Crossing (R1-6) sign may be used to remind road users of laws regarding right-of-way at an unsignalized pedestrian crossing. The legend STATE LAW may be shown at the top of the sign. The legend YIELD TO may be used in conjunction with the appropriate symbol. If used, the In-Street Pedestrian Crossing sign shall have a black legend (except for the red YIELD sign symbol) and border on either a white and/or fluorescent yellow-green background. If the In-Street Pedestrian Crossing sign is placed in the roadway, the sign support shall comply with the breakaway requirements of the latest edition of AASHTO's "Specification for Structural Supports for Highway Signs, Luminaires, and Traffic Signals". The In-Street Pedestrian Crossing sign may be used seasonably to prevent damage in winter because of plowing operations, and may be removed at night if the pedestrian activity at night is minimal.

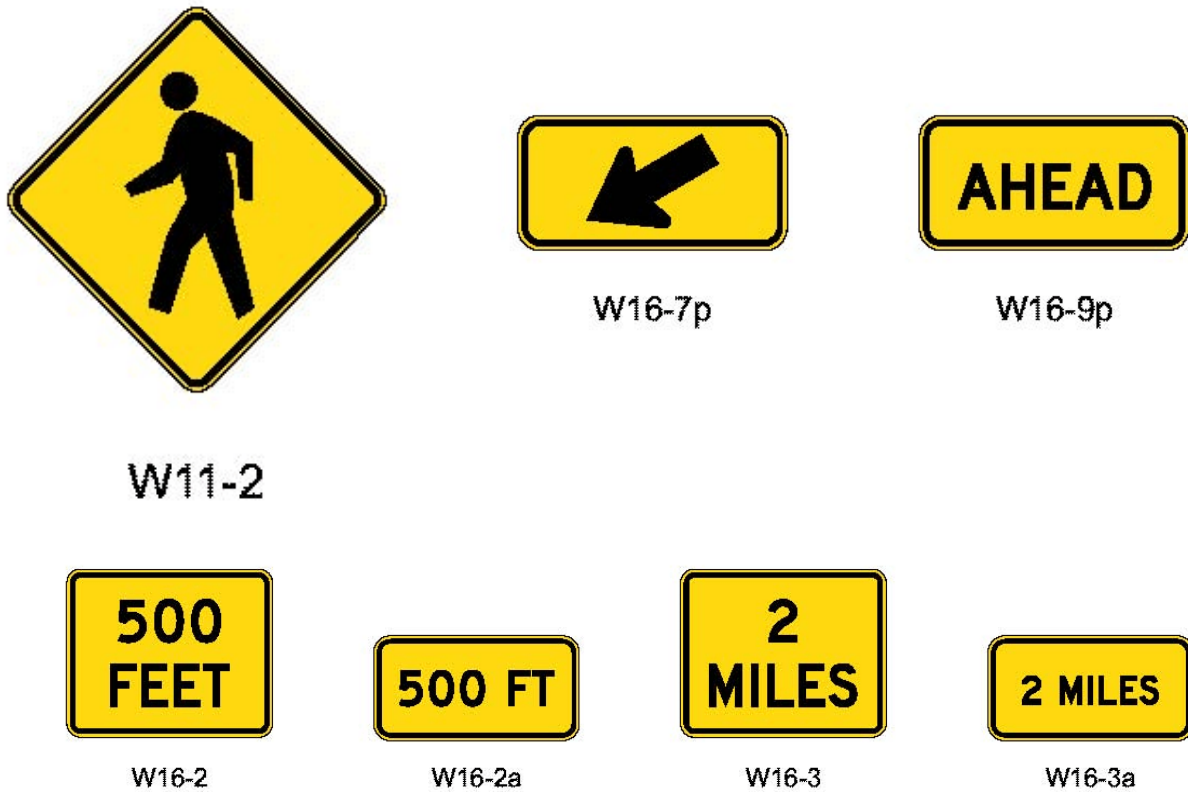
Figure 7 - Pedestrian Crossing & Supplemental Plaque Warning Signs

Figure 7 shows the warning sign for use at and in advance of a marked pedestrian crossing (W11-2). Also included are variations of the supplemental plaques that can be used in conjunction with the warning sign. The sign code as assigned in the OMUTCD is shown below the signs. This code is used to identify the sign and its type.

The pedestrian warning sign (W11-2) may be used to alert road users in advance of locations where unexpected entries into the roadway by pedestrians and other crossing activities might occur. When used in advance of a crossing, the warning sign may be supplemented with supplemental plaques such as those shown above to provide advance notice to road users of crossing activity. When used at the crossing, the sign shall be supplemented with a diagonal downward pointing arrow (W16-7p) plaque to indicate the location of the crossing.

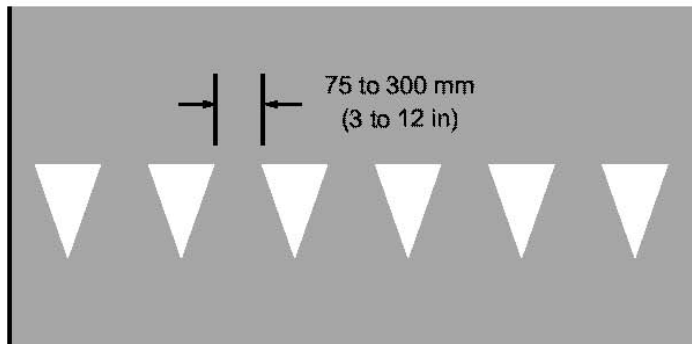
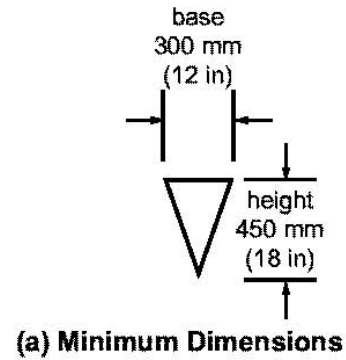
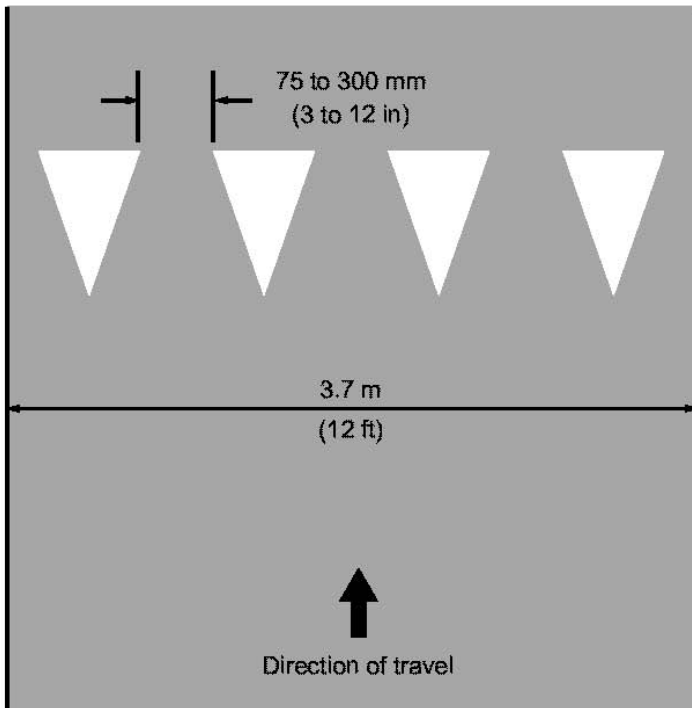
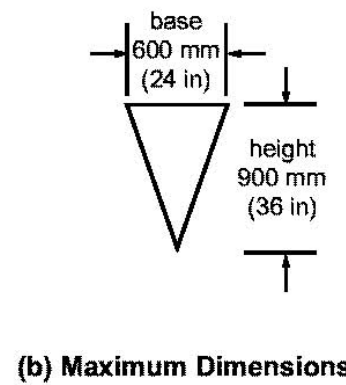
Figure 8 - Yield Line Layouts

Figure 8 details the layout and use of yield lines for use at mid-block crossings. These are also referred to as “sharks teeth”.

Notes:
 Triangle height is equal to 1.5 times the base dimension.
 Yield lines may be smaller than suggested when installed on much narrower, slow-speed facilities such as shared-use paths.

Yield lines shall consist of a row of solid white isosceles triangles pointing toward approaching vehicles extending across approach lanes to indicate the point at which the yield is intended or required to be made. Yield lines may be used to indicate the point behind which vehicles are required to yield in compliance with a YIELD (R1-2) sign or a Yield Here to Pedestrians (R1-5) sign. Yield signs when used at an unsignalized mid-block crosswalk, should be placed adjacent to the Yield Here to Pedestrians sign located 20 to 50 feet in advance of the nearest crosswalk line, and parking should be prohibited in the area between the yield line and the crosswalk (see **Figure 9**). Drivers who yield too close to crosswalks on multi-lane approaches place pedestrians at risk by blocking other drivers' views of pedestrians.

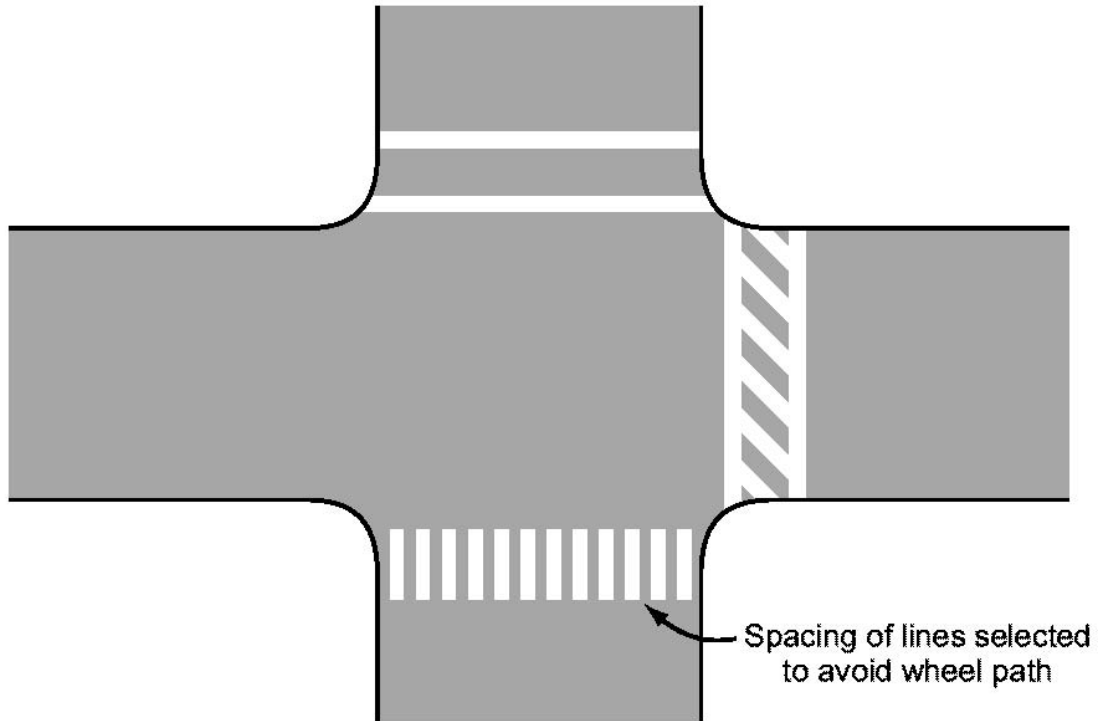
Figure 10 - Examples of Crosswalk Markings

Figure 10 details the use of various types of crosswalk markings. It should be noted that while the illustration shows the markings in use at an intersection, these markings can be used at a mid-block location.

When crosswalk lines are used, they typically consist of solid white lines that mark the crosswalk boundaries. If transverse lines are used to mark a crosswalk, the gap between the lines should not be less than 6 feet. If diagonal or longitudinal lines are used without transverse lines to mark a crosswalk, the crosswalk should be not less than 6 feet wide. Crosswalk lines, if used on both sides of the crosswalk, should extend across the full width of pavement. Because non-intersection pedestrian crossings are generally unexpected by the road user, warning signs should be installed and adequate visibility should be provided by parking prohibitions. For added visibility, the area of the crosswalk may be marked with white diagonal lines at a 45-degree angle to the line of the crosswalk or with white longitudinal lines parallel to traffic flow as shown in **Figure 10**. When diagonal or longitudinal lines are used to mark a crosswalk, the transverse crosswalk lines may be omitted. This type of marking may be used at locations where substantial numbers of pedestrians cross without any other traffic control device, at locations where physical conditions are such that added visibility of the crosswalk is desired, or at places where a pedestrian crosswalk might not be expected. If used, the diagonal or longitudinal lines should be 12 to 24 inches wide and spaced 12 to 60 inches apart. The marking design should avoid the wheel paths, and the spacing should not exceed 2.5 times the line width.

To provide a higher degree of visibility to motorists that there is a marked mid-block crosswalk two alternative methods of striping the crosswalks are recommended. The first method would be to continue to use the parallel lines that are perpendicular to the roadway with the area between the lines filled in with diagonal white lines. The transverse lines could be omitted in this scenario. The second method to increase the visibility of the crosswalk would be to use longitudinal lines parallel to the traffic flow to mark the crosswalk. The marking design should avoid the wheel paths of the vehicles traveling on the roadway. Examples of these pavement markings can be seen **Figure 10**.

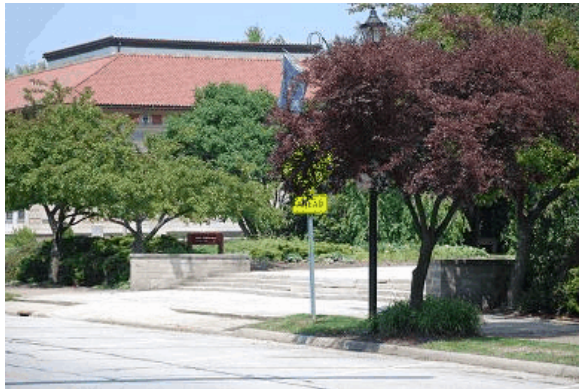
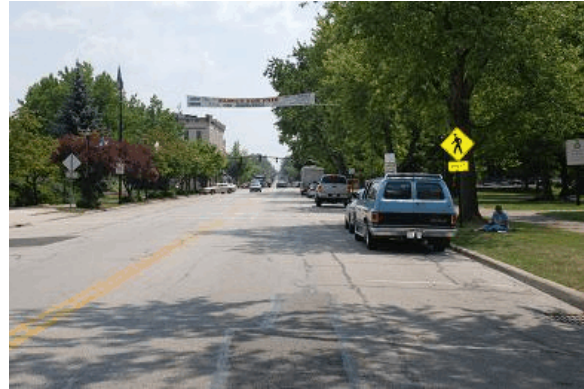
There are pedestrian warning signs (W11-2) with the Ahead supplemental plaque (W16-9p) located just north and south of the North Main crosswalk. Both signs and plaques have the fluorescent yellow-green background. These sign configurations are consistent with an advance warning situation. Photos showing the signs and their placement can be seen in the following pictures.

North Main Looking North

North Main Looking South

The sign combination for the southbound traffic should be moved further north to provide adequate advance notice to drivers. It is recommended to remove the advance warning sign for northbound direction of travel. These existing sign installations should be replaced with the pedestrian warning sign (W11-2) and arrow plaque (W16-9p) facing each direction at the crosswalk. The new sign locations should be placed as close as possible to the actual crosswalk location. The existing northbound warning sign and supplemental plaque is obscured from the motorists view due to the growth of a tree. This tree would most likely obscure the view of a sign placed at the crosswalk as well. This tree should be regularly trimmed to ensure the warning signs can be seen by the oncoming northbound traffic from an adequate distance so the driver has time to initiate a response if necessary.

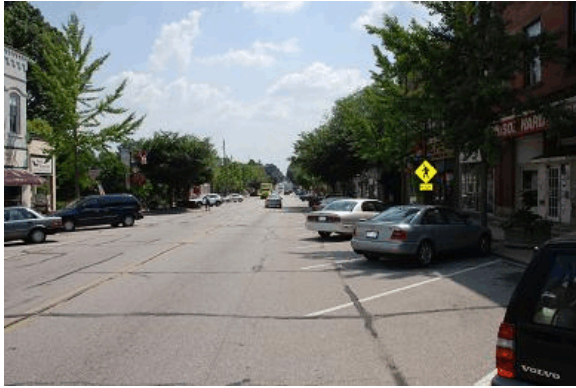
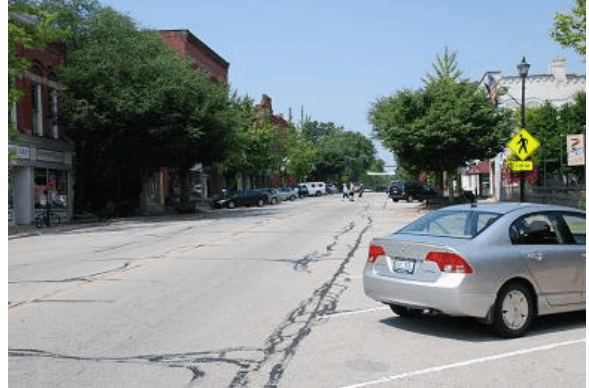
There are pedestrian warning signs (W11-2) with the Ahead supplemental plaque (W16-9p) located north and south of the South Main crosswalk. Both signs and plaques have the fluorescent yellow-green background. These sign configurations are consistent with an advance warning situation. Photos showing the signs and their placement can be seen in the following pictures.

South Main Looking South

South Main Looking North

It is recommended to remove the advance warning signs for both the northbound and southbound directions. There is already a southbound advance warning installation recommended north of the North Main Crosswalk. Pedestrian warning signs (W11-2) and the arrow plaque (W16-9p) should be erected at the crosswalk for the northbound and southbound directions. The signs should be placed on the sidewalk bump out area so as to not be blocked by a parked vehicle. The bump out is the area where the sidewalk area has been extend out into the street to shorten the amount of roadway that a pedestrian has to cross. All new signs should be of the same background color as others used throughout the study area.

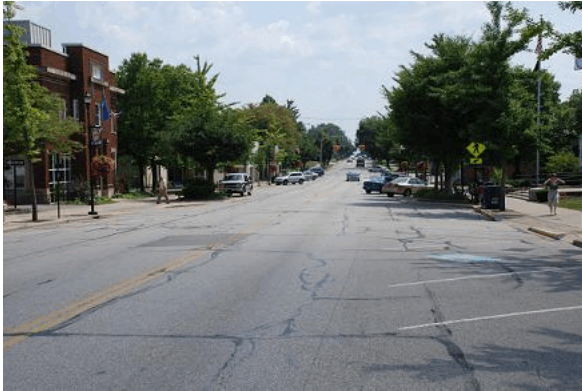
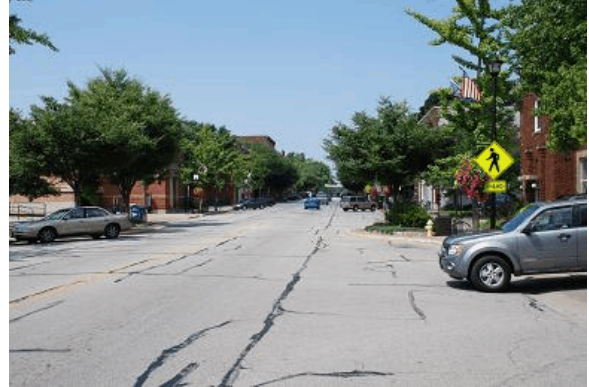
There is a pedestrian warning sign (W11-2) and arrow plaque (W16-7p) located at the crosswalk facing the southbound traffic. The sign is located behind the bump out and the on-street parking spaces. There is an advance pedestrian warning sign combination just south of the crosswalk facing the oncoming northbound traffic. Both signs and plaques have the fluorescent yellow-green background. Photos showing the signs and their placement can be seen in the following pictures.

Old City Hall Looking South

Old City Hall Looking North

It is recommended to move the northbound advance warning sign combination further south to provide adequate notice to motorists that they are entering an area where pedestrians will be entering and crossing the roadway. A warning sign (W11-2) and arrow plaque (W16-7p) should be erected at the crosswalk for the northbound traffic. This sign combination should be located at the crosswalk and out on the bump out so that the visibility of the sign is increased. The existing southbound sign combination should be re-located to the crosswalk and out on the bump out so that the visibility of the sign is increased. By locating these warning sign combinations out on the bump outs it removes them from being behind the on-street parking and increases their visibility. All new signs should continue to maintain the same background color as those in use throughout the study are to provide uniformity.

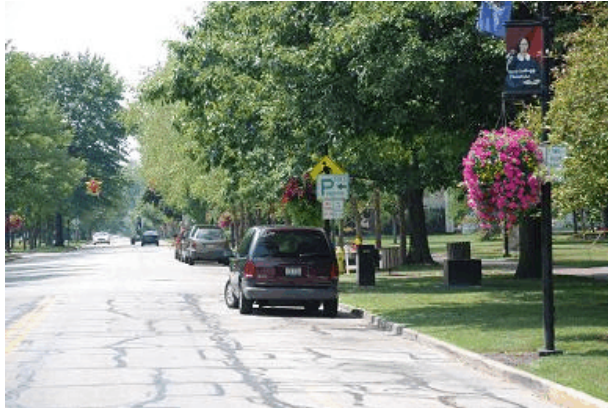
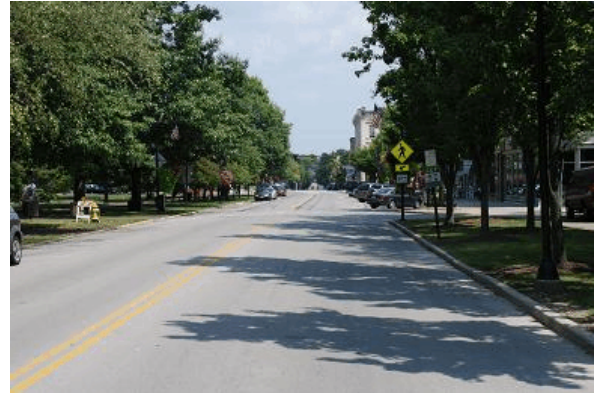
The West College crosswalk is properly signed with Pedestrian Warning signs (W11-2) facing each direction of travel and the supplemental arrow plaque (W16-7p) pointing to the crosswalk location. Both signs and plaques have the fluorescent yellow-green background. The eastbound warning sign and supplemental plaque is obscured from the motorists view due to the placement of a free parking sign. Photos showing the signs and their placement can be seen in the following pictures.

West College Looking West

West College Looking East

The parking sign that currently obscures the westbound warning sign should be relocated so the sign can be clearly seen by oncoming motorist.

There are no advance warning signs in either direction along West College Street that let motorists know that this is an area where pedestrians may be entering the roadway at a designated mid-block crossings. It is recommended that a pedestrian warning sign (W11-2) with an Ahead plaque (W16-9p) be erected just to the east of Professor Street to alert motorists that they are entering an area where pedestrians are crossing the roadway. These signs should be of the same color as those currently posted throughout the area.

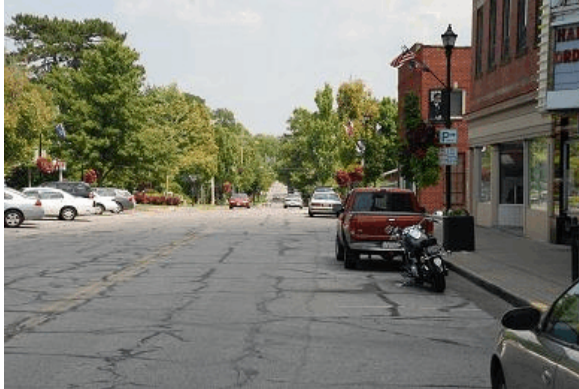
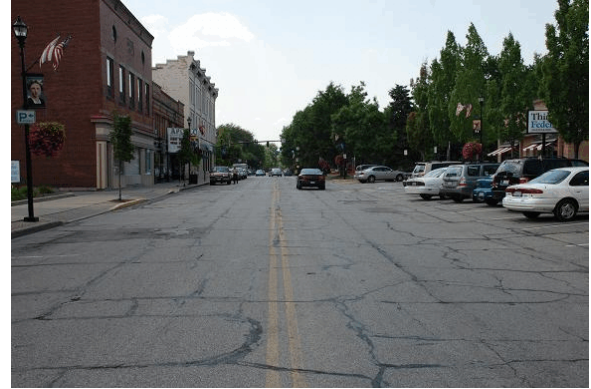
There are currently no pedestrian warning signs or advance warning signs located at the East College crosswalk. Photos showing the view of the crosswalk from the east and west can be seen in the following pictures.

East College Looking East

East College Looking West

Pedestrian warning signs (W11-2) with the arrow plaque (W16-7p) should be erected at the crosswalk for both the eastbound and westbound traffic. An advance pedestrian warning sign should be erected east of the crosswalk consisting of the pedestrian warning sign (W11-2) and the ahead plaque (W16-9p). All new signs should have the same background color as those used throughout the study area to provide uniformity with all the crosswalk related signs.

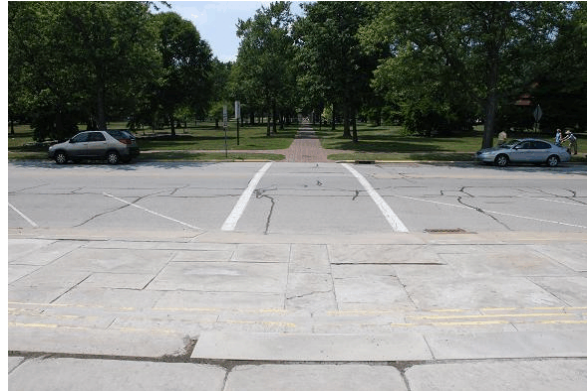
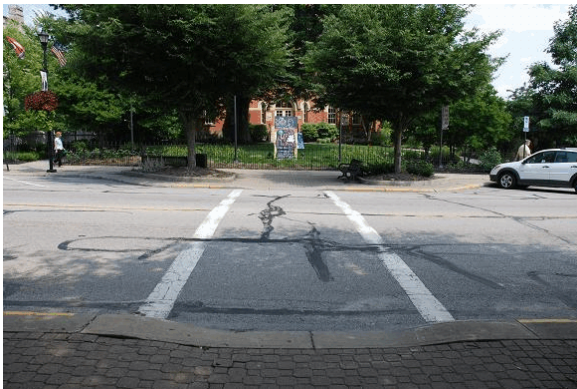
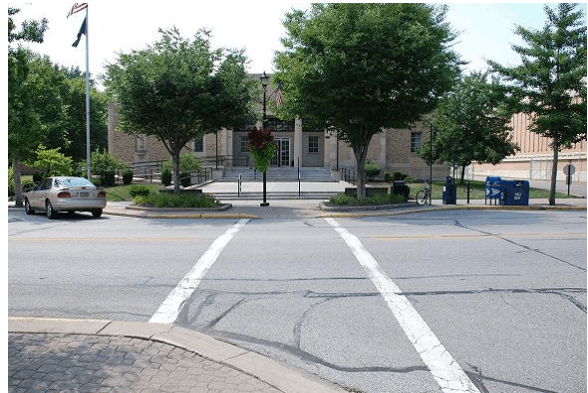
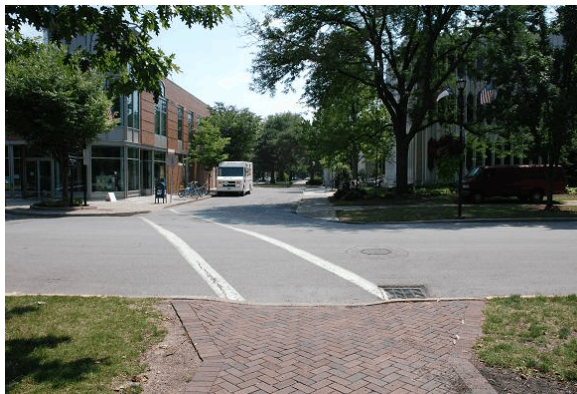
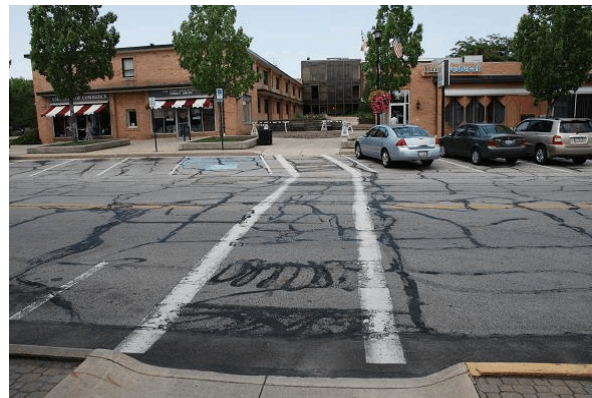
All five crosswalk locations are currently employing the standard crosswalk pavement markings. Each location is marked with two parallel white lines perpendicular to the roadway. The crosswalk lines at all five locations extend across the full width of the roadway from curb to curb. The photos on this page show the existing crosswalk pavement markings for the five crosswalk locations under study.

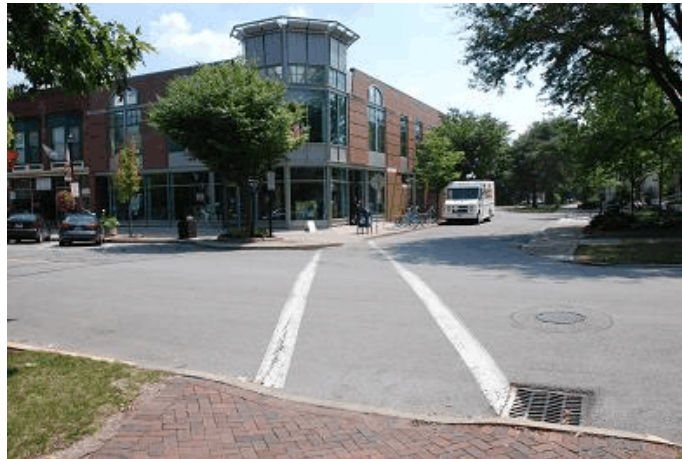
The West College crosswalk runs diagonally across the roadway from the southeast corner to the northwest corner of the West College Street and College Place intersection. This is a heavily used crosswalk as Tappan Square is located on the north side of West College Street and the Oberlin College bookstore is located along the south side of West College Street. There are no other marked crosswalks at this intersection.

To improve the safety and efficiency of the intersection operation two improvements are recommended. The first recommendation is to re-align the existing crosswalk so it runs from the northwest corner to the southwest corner. This will shorten the length of the crosswalk which will shorten the time it will take a pedestrian to cross West College Street. It is also recommended to stripe a crosswalk across the College Place. This will provide marked and designated crosswalks on two approaches of the intersection. At a three-way intersection two crosswalks will allow a pedestrian to traverse the intersection to any quadrant.

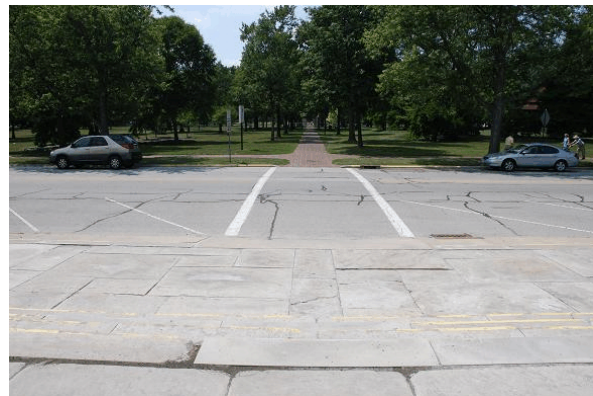
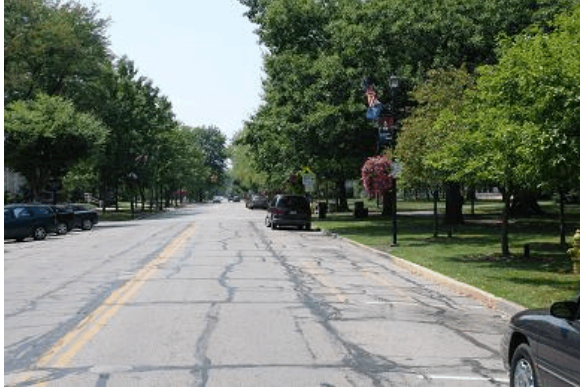
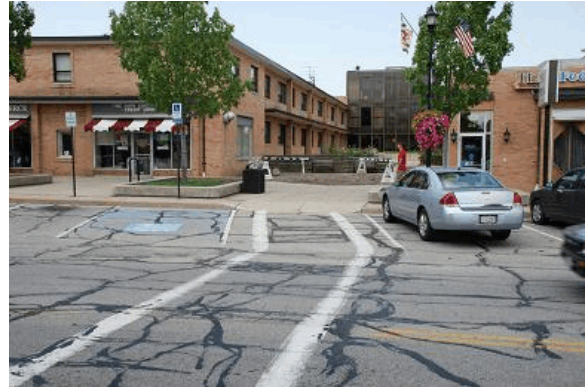
At the North Main, West College, and East College crosswalks the on-street parking is adjacent to the crosswalks. This makes it difficult for oncoming traffic and pedestrians waiting to cross the street to see each other if the spaces adjacent to the crosswalk are occupied, especially with an SUV or van. These configurations can be seen in the following photos.

In order to improve the visibility at these locations the adjacent parking spaces should be eliminated. The North Main crosswalk currently restricts parking near the crosswalk along the west side of North Main Street. The first parking space on each side of the crosswalk along the east side of North Main Street should be eliminated. The first parking space along the north side of West College Street on each side of the crosswalk should be eliminated. The first parking space along the north side of East College Street on each side of the crosswalk should be eliminated. To ensure vehicles do not park in these areas the curbs could be painted yellow like the west side of North Main Street at the crosswalk. This setup can be seen in the following picture.

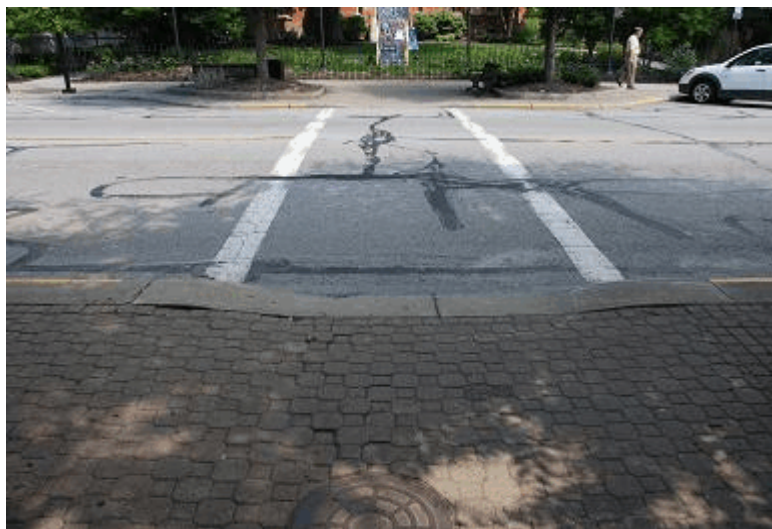
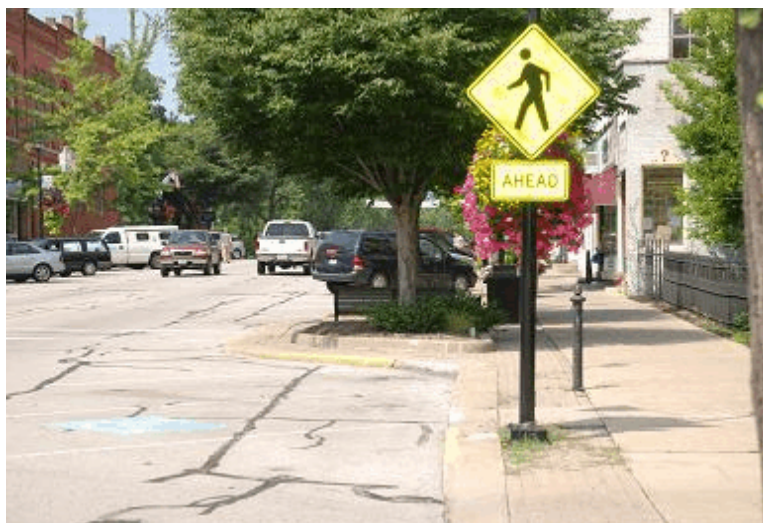
Bump Out @ South Main Crosswalk

Another option to improve the visibility for both the pedestrian and motorists would be to construct bump outs (curb extensions) at the West College, North Main, and East College crosswalks. Bump outs are already present at the South Main and Old City Hall crosswalks. These bump outs improve the visibility of pedestrians waiting to cross by bringing them closer to the center of the driver's cone of vision and by minimizing the impact of parked vehicles on pedestrian visibility. Bump outs are an extension of the sidewalk area across the parking lanes to the edge of the travel lanes. This feature would narrow the distance of the road that a pedestrian has to cross. A shorter distance to cross would lessen the amount of time a pedestrian is in the roadway. The following photos show an example of a bump out at the South Main crosswalk. It should be noted that the curbs of the bump outs are painted yellow to emphasize there is no parking allowed along the bump out.

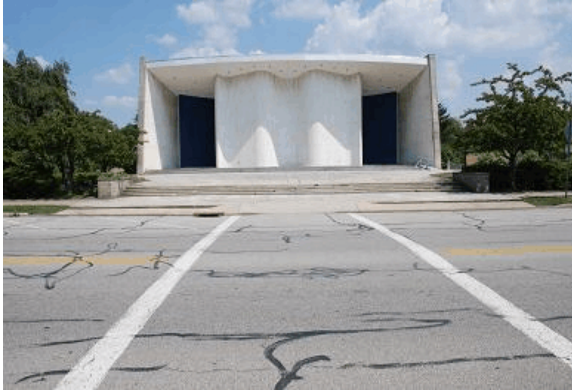
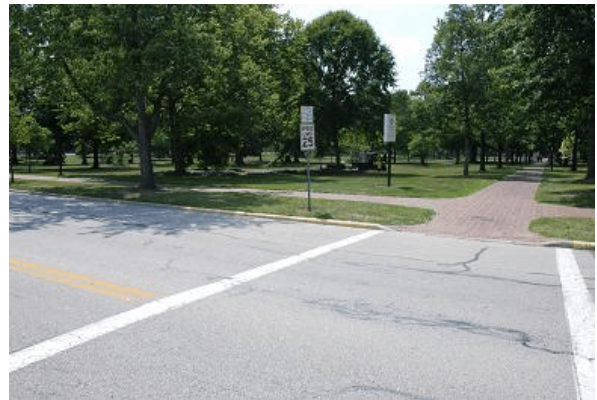
North Main Crosswalk

East Curb Ramp

West Curb Ramp

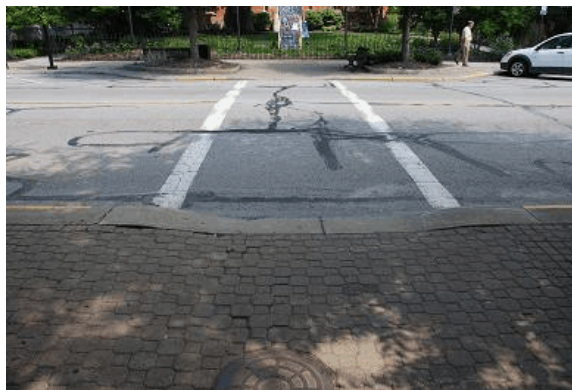
East Curb Ramp

The curb ramps at the South Main crosswalk should be retro-fitted with a detectable warning surfaces consisting of truncated domes.

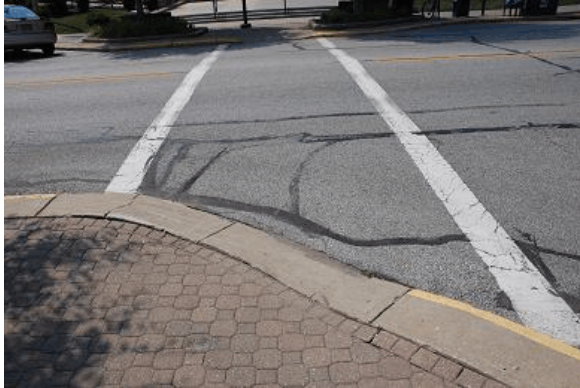
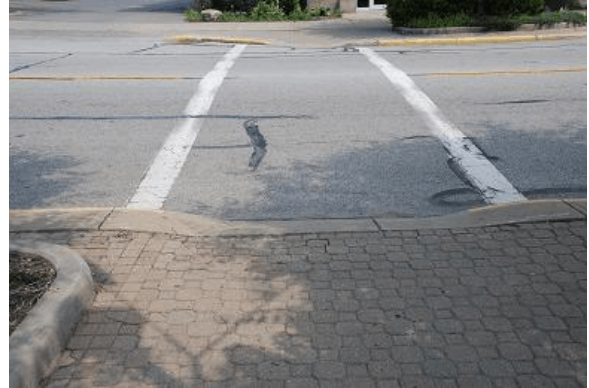
Old City Hall Crosswalk

East Curb Ramp

West Curb Ramp

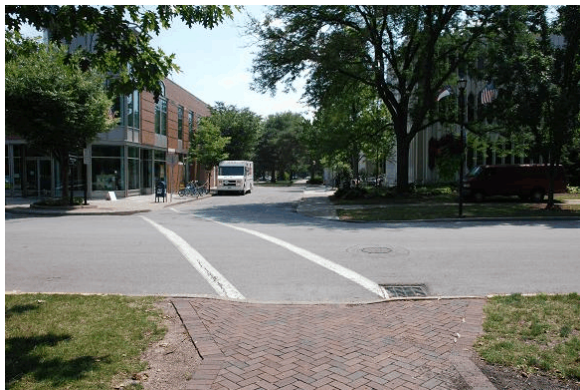
North Curb Ramp

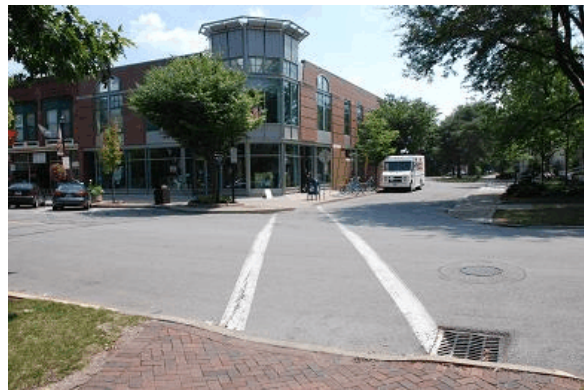
South Curb Ramps

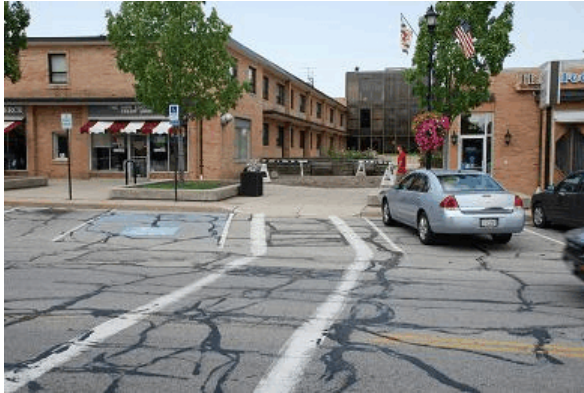
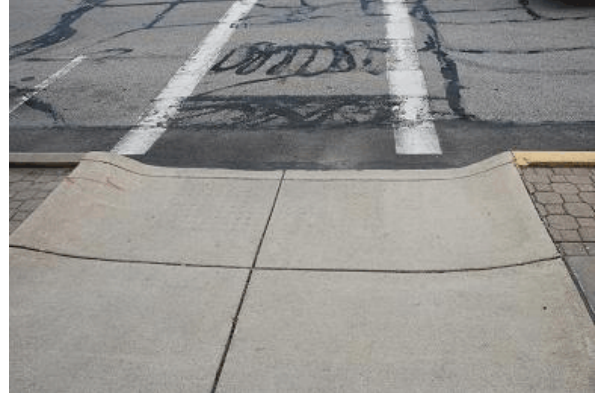
East College Crosswalk

The curb ramps at the East College crosswalk appear to have had the truncated domes stamped into the concrete when the curb ramp was constructed. These domes have since become worn down and have lost their functionality. The curb ramps at the East College crosswalk should be retro-fitted with a detectable warning surfaces consisting of truncated domes.
