TRAFFIC ENGINEERING STUDY

Various Crosswalk Locations

Oberlin, Ohio

November 14, 2007

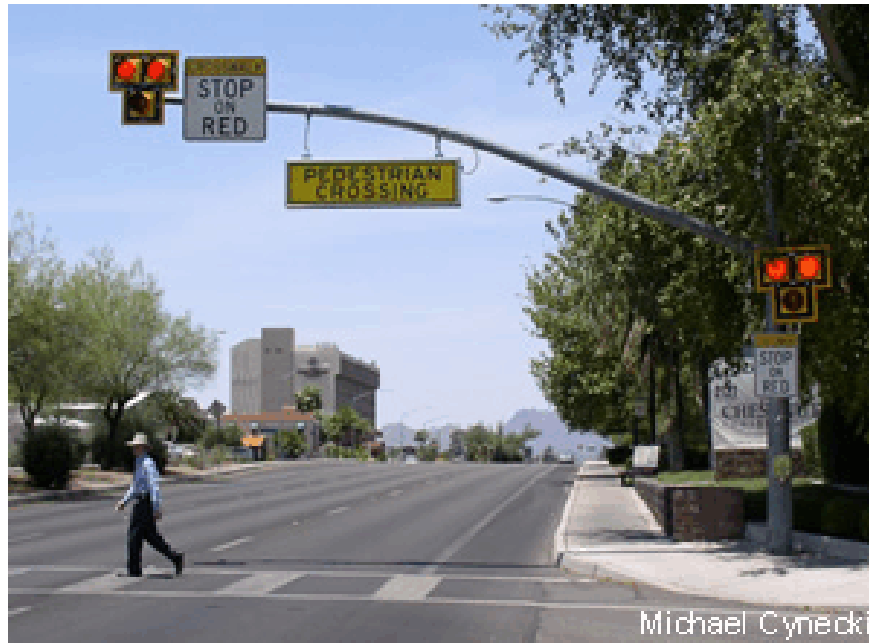
HAWK Signal

When not activated, the signal is blanked out. The HAWK signal is activated by a pedestrian push button. The overhead signal begins flashing yellow and then solid yellow, advising drivers to prepare to stop. The signal then displays a solid red and shows the pedestrian a “Walk” indication. Finally, an alternating flashing red signal indicates that motorists may proceed when safe, after coming to a full stop. The pedestrian is shown a flashing “Don’t Walk” with a countdown indicating the time left to cross. The following photo shows a HAWK signal installation.
