DAM SAFETY INSPECTION REPORT

OBERLIN WATERWORKS UPGROUND NO. 1&2

FILE NUMBER: 1221-018

INSPECTED: SEPTEMBER 18, 2018

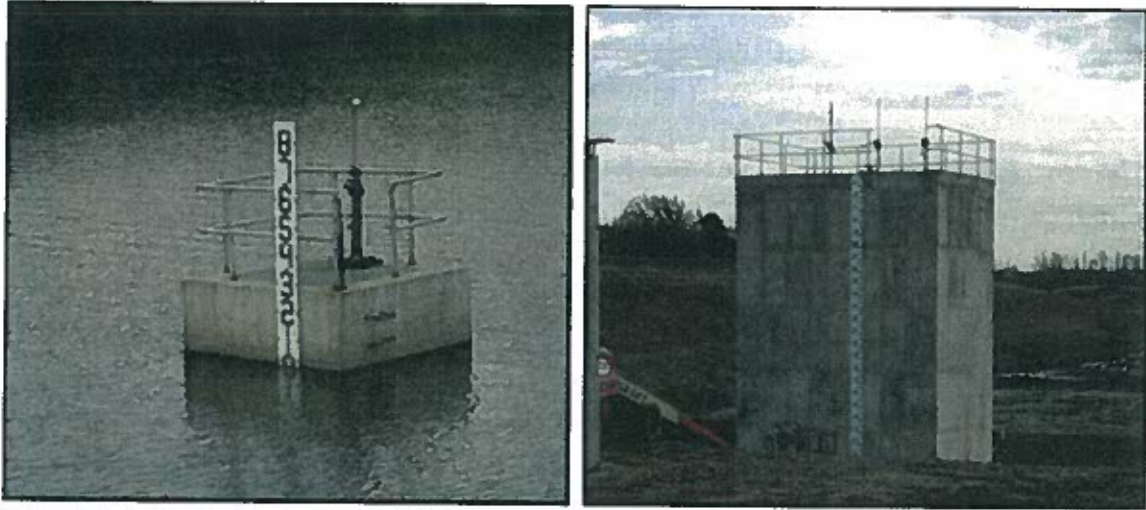
3. A staff gauge helps the owner more accurately document pool levels during flood events and during routine inspections. It is very helpful to correlate seepage through drains to pool level. Please note that the graduations/numbers should extend beneath the lake level so that lowering of the pool (should it be needed or desired) can be monitored. It should be positioned to allow easy reading from a safe location. An example of a staff gauge is shown below.
